Property Inspection Report Summary

**123 Dogwood Street
North Myrtle Beach, South Carolina 29582**

**April 24th, 2024
9:00 AM**

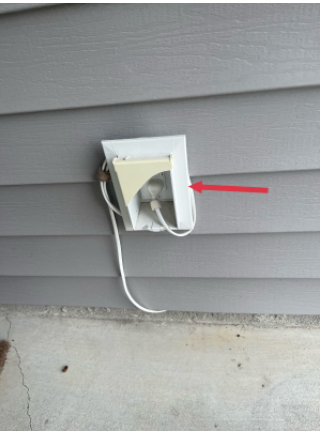
GFCI Section 3.6	Description	• Functional	Repair or Replacement Needed <i>Recommend replacement of cover.</i>
	Condition	• Cover for GFCI receptacle at the entrance of the front door is broken.	
	Location	• Exterior receptical

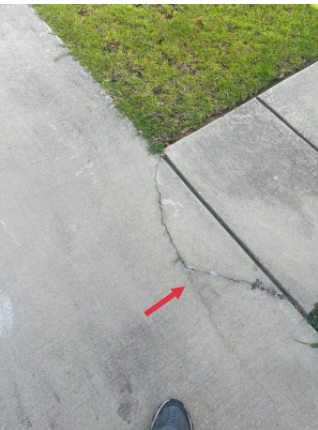
Driveways Section 1.12	Description	• Concrete	Maintenance Needed <i>Minor cracks are expected in concrete driveways over time, but do not indicate a serious issue. Recommend sealing cracks to prevent water from seeping into cracks and eroding soil beneath the concrete.</i>
	Condition	• Observed minor cracking.

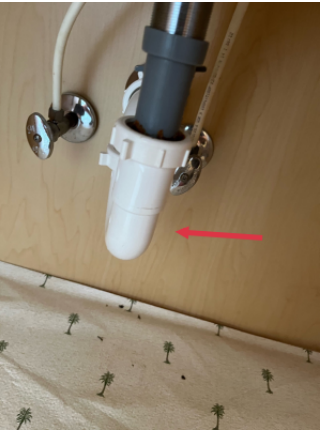
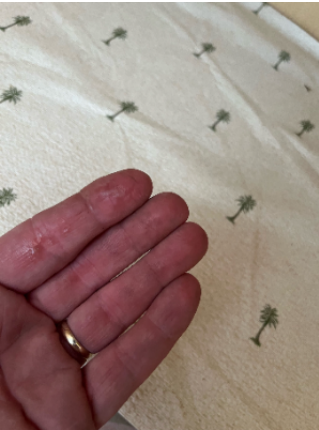
Drain, Waste,
Vent Piping 1
Section 5.1

- Description
- PVC
- Condition
- Minor leak observed when water is draining in guest bathroom sink.
- Location
- Guest bathroom under sink.

Repair or Replacement Needed
P-trap under guest bath sink leaking. If left unrepaired, could lead to wood rot. This is an easily correctable issue for handyman or plumber.

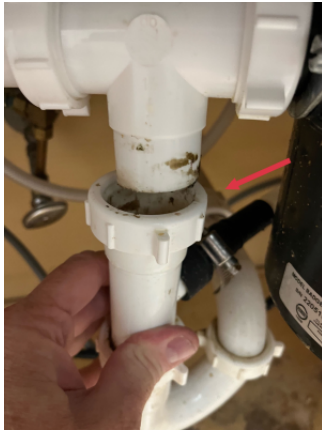
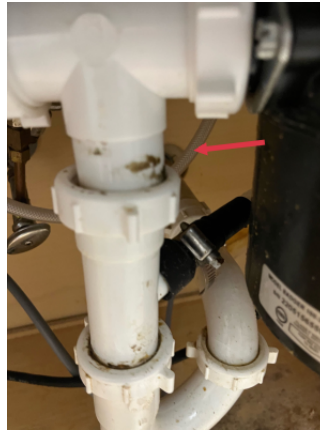
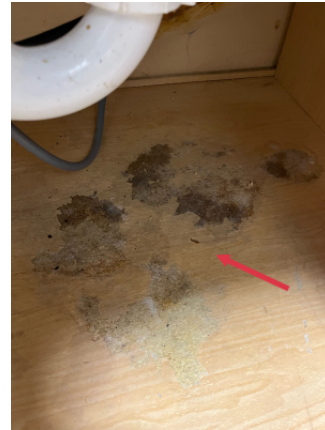
**Drain, Waste,
Vent Piping 2**
Section 5.2

| Condition | • Drain line under kitchen sink is loose and leaks when water is draining. |
| Location | • Under kitchen sink. |

Recommend repair.

Leak is an easily correctable issue by handyman or plumber. Repair or Replacement of damaged cabinet bottom can be made by handyman or contractor,

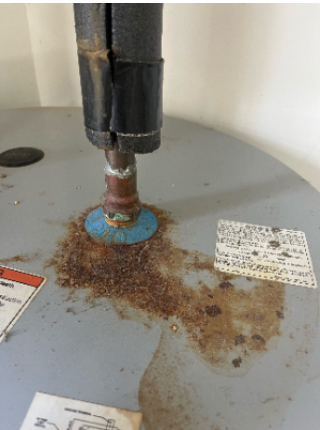
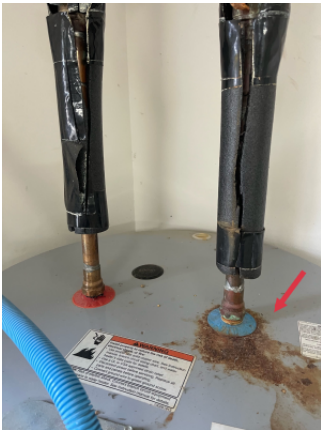
Water Heater
Section 5.3

- Description
- Conventional
- Condition
- Rust observed at cold water input line.

Minor rust was observed at cold water input line. No leak was observed. One possible reason for the cause of this rust could be galvanic reaction which is a chemical reaction of two different types of metals being connected together. Another possible cause could be from a previous leak that has since been repaired. However, unable to determine the exact cause of the rust. Recommend having condition checked by a licensed plumber.
