Property Inspection Report Summary

Demo Report - 10013 River Drive Las Vegas, NV 89119

Date of Inspection
December 10th, 2020
11:30 AM

Summary of Major Issues

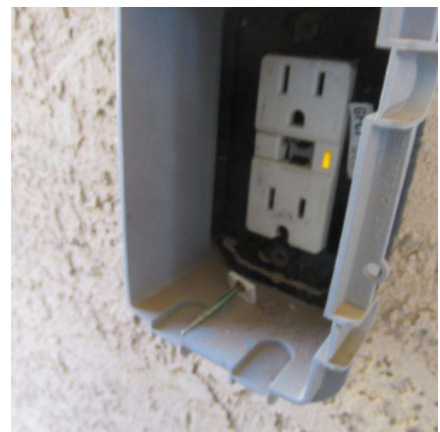
GFCI Section 3.3

Description	<ul style="list-style-type: none">Present	Repair or Replace <i>The test button on the GFCI is broken and should be repaired or replaced immediately.</i>
Condition	<ul style="list-style-type: none">GFCI Inoperable	
Location	<ul style="list-style-type: none">ExteriorSouth-West Corner

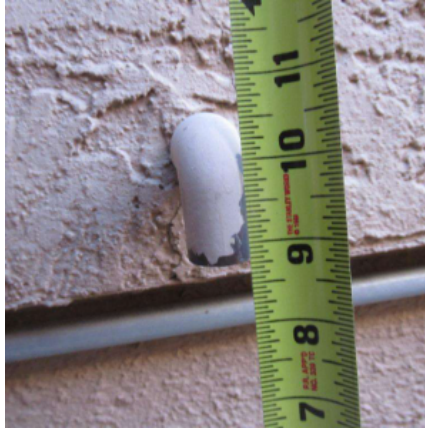
Drain, Waste, Vent Piping Section 5.1

| Condition | <ul style="list-style-type: none">• Improper Length |
| Location | <ul style="list-style-type: none">• Exterior• West Wall |

Water heater discharge pipe is too short/far from ground. Steam dissipation can cause scalding to those standing nearby. Typically this should terminate 6 inches from the ground, but may vary by jurisdiction.

Repair or Replace

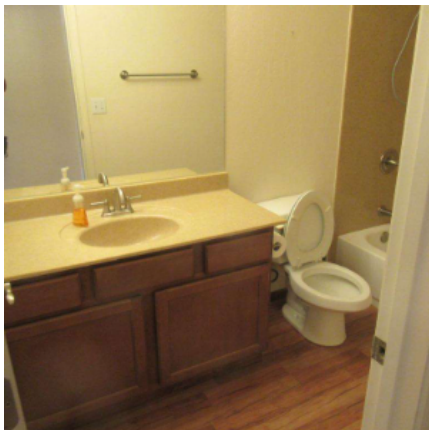
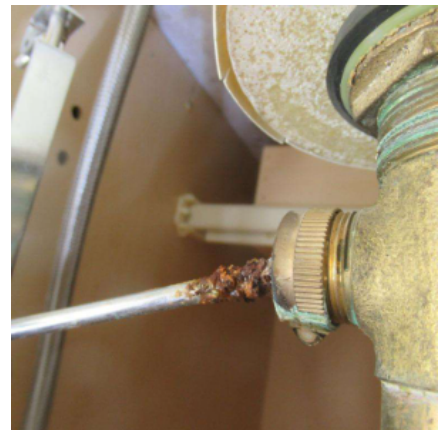
Bathroom Sinks Section 5.2

| Condition | <ul style="list-style-type: none">• Leaking |
| Location | <ul style="list-style-type: none">• Master Bathroom |

A leak is present at the stopper rod/drain connection. The mechanism can be dismantled to check seals for wear or cracks.

Repair or Replace
