Property Inspection Report

Demo Report - 10013 River Drive Las Vegas, NV 89119

Date of Inspection
December 10th, 2020
11:30 AM

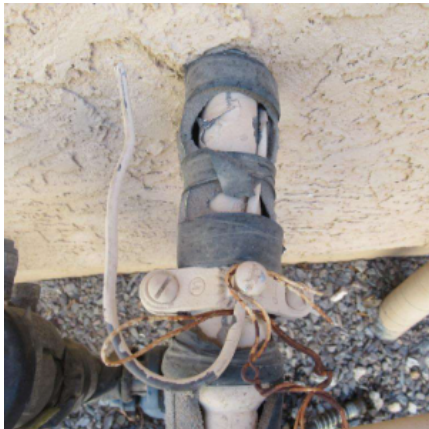
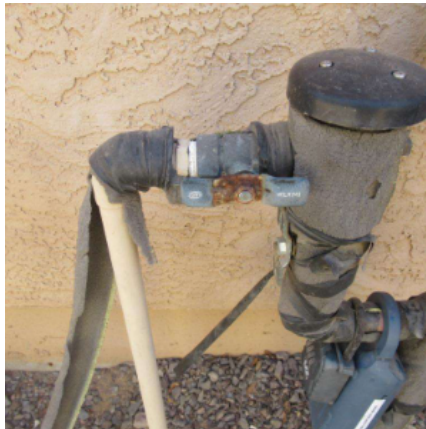
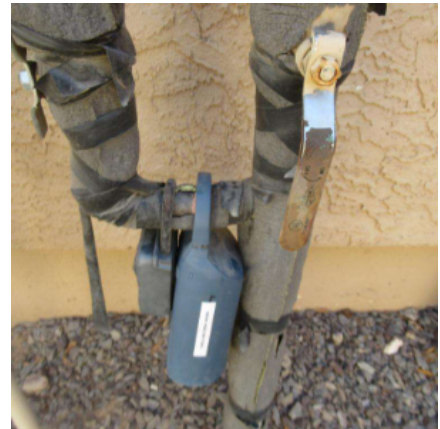
1.1 Hose Bibbs / Outdoor Faucets Exterior	Description	• Anti-siphon	Location	• Exterior • West Side
	Condition	• Deteriorated Insulation	Risk	• Freezing during extreme weather in winter

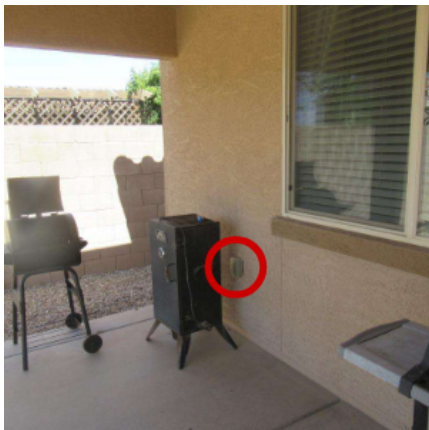
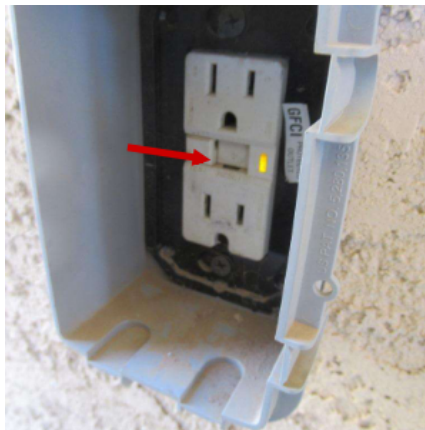
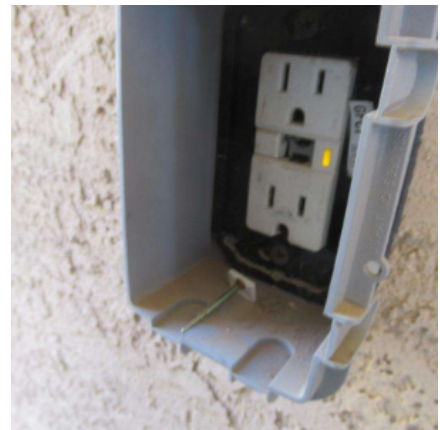
| Condition | <ul style="list-style-type: none">• GFCI Inoperable | Risk | <ul style="list-style-type: none">• Electrocution Hazard• Inoperable Outlets |

Image 3.3.1 Broken GFCI Location

Image 3.3.2 Broken GFCI Test Button

Image 3.3.3 Broken GFCI Test Button

Repair or Replace - Immediately: The test button on the GFCI is broken and should be repaired or replaced immediately.

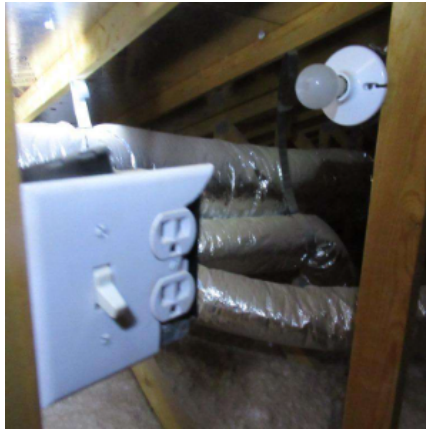
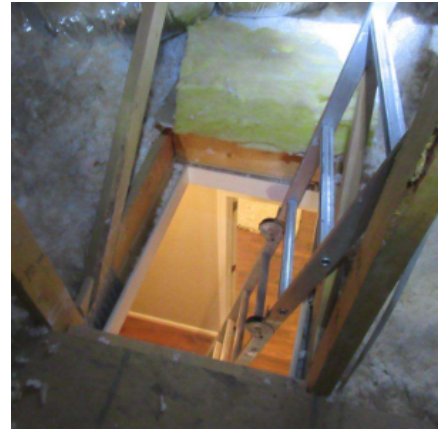
| Condition | <ul style="list-style-type: none">• Damaged | Risk | <ul style="list-style-type: none">• Electrocution Hazard |

Image 3.4.1 Broken Outlet Cover

Repair or Replace

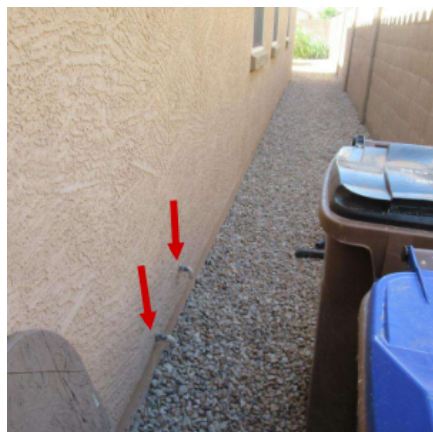
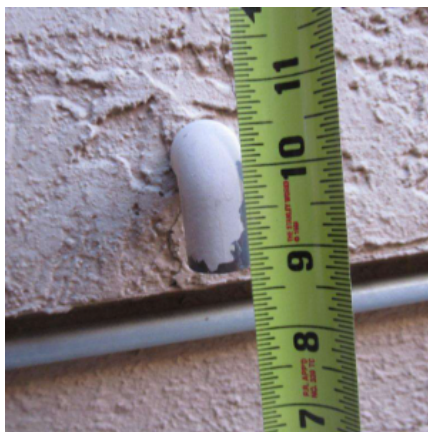
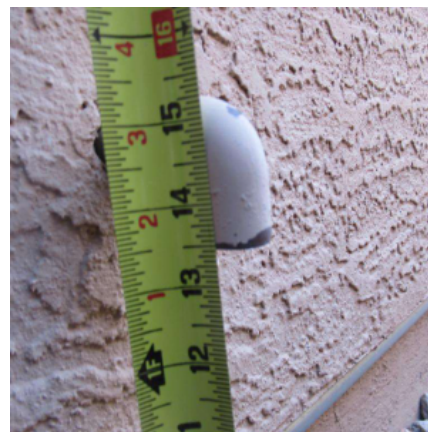
Image 5.1.1 Discharge Pipes on West Wall

Repair or Replace - Immediately: Water heater discharge pipe is too short/far from ground. Steam dissipation can cause scalding to those standing nearby. Typically this should terminate 6 inches from the ground, but may vary by jurisdiction.

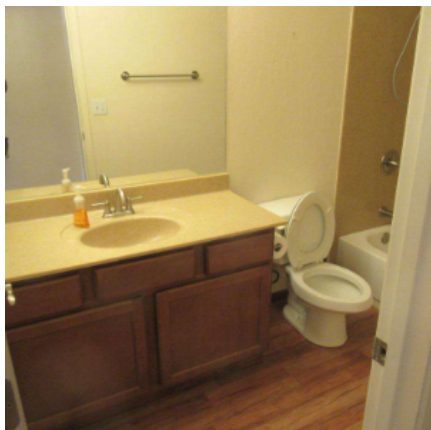
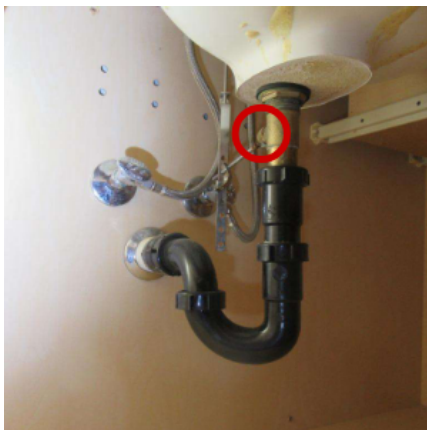
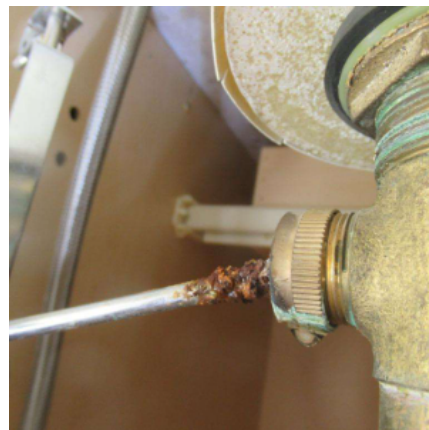
Repair or Replace - Immediately: A leak is present at the stopper rod/drain connection. The mechanism can be dismantled to check seals for wear or cracks.

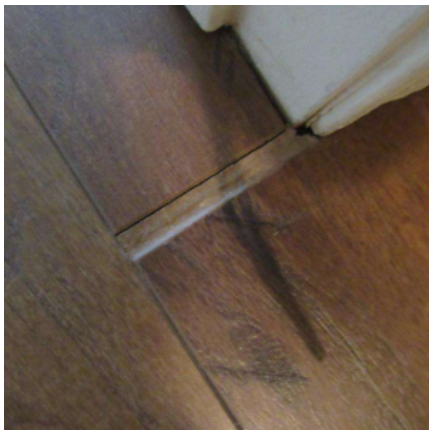
Description	• Hardwood • Ceramic Tile	Location	• Master Bedroom • Kitchen
Condition	• Gap • Minor Delamination	Risk	• Continued Delamination • Cosmetic

Image 6.1.1 Hardwood Flooring Gap - Master Bdrm Entry

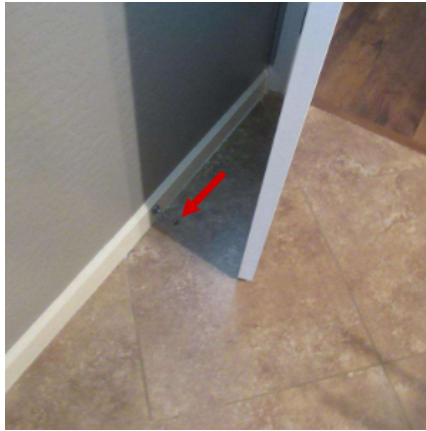
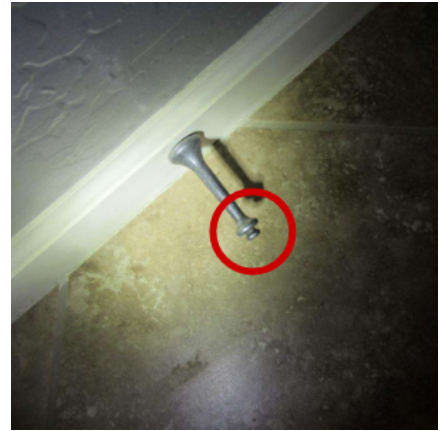
Repair or Replace Two of the door stops are missing the rubber bumpers that absorb the impact without denting the door. These can be purchased at your local hardware store and installed easily.

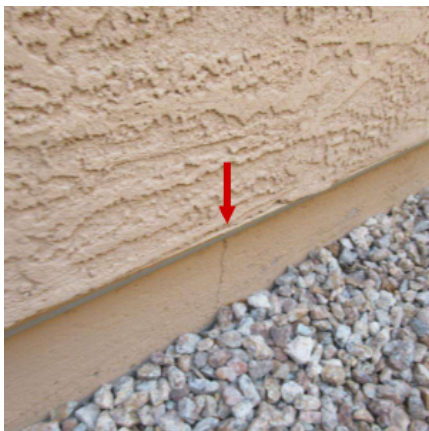
Image 7.1.1

7.1 Foundation Material Structure	Description	• Concrete	Location	• East Side of Home
	Condition	• Hairline Cracked	Risk	• Normal Settlement

There are typical settling cracks in the foundation walls that would not need a specialist evaluation.
