Property Inspection Report

**1234 Demonstration Way
Fort Lauderdale, FL 33304**

**July 16th, 2023
8:00 AM**

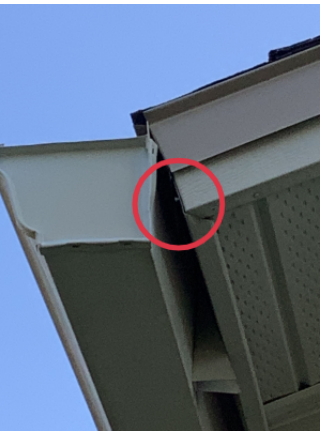
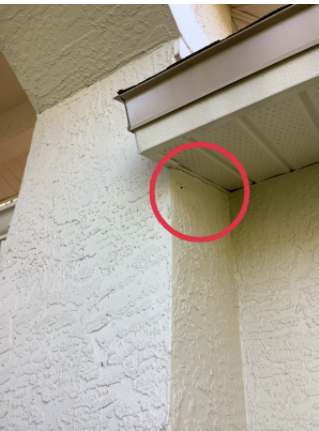
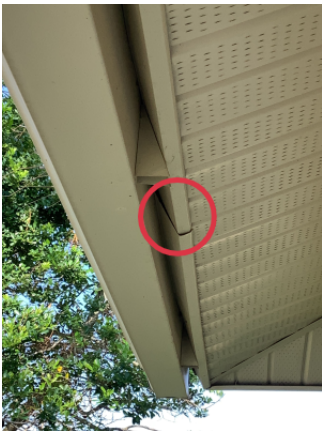
| Condition | <ul style="list-style-type: none">• Missing Caulking |

Monitor
Reset nails that have worked themselves out. Recommended.

Caulk seams where there are gaps where the fascia meets the soffit. Recommended.

Caulk seams where there are gaps where the fascia meets the structure.

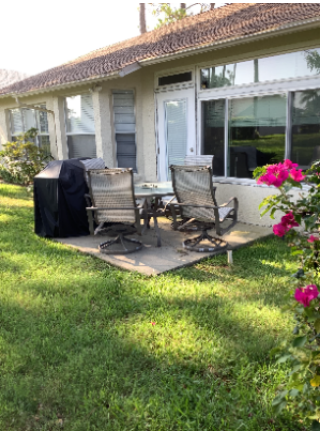
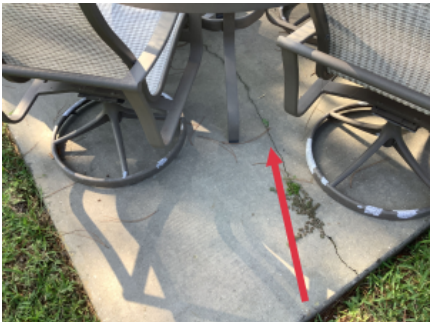
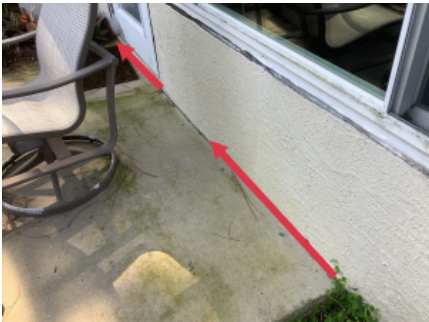
Monitor
Recommend filling cracks in patio slab. These are from normal settling.

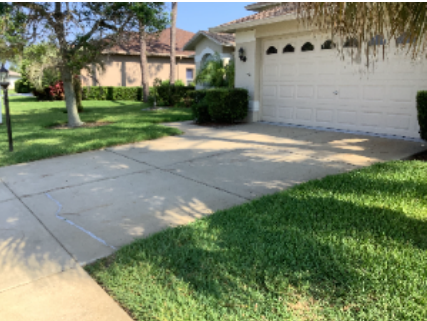
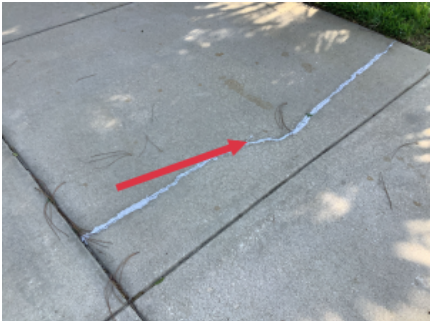
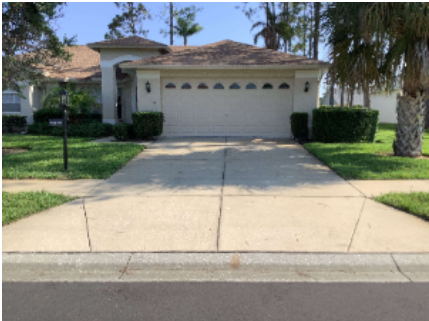
Monitor
There are predictable cracks in the driveway that would not necessarily need to be serviced.
Recommend filling the cracks to help prevent moisture intrusion under the slab.

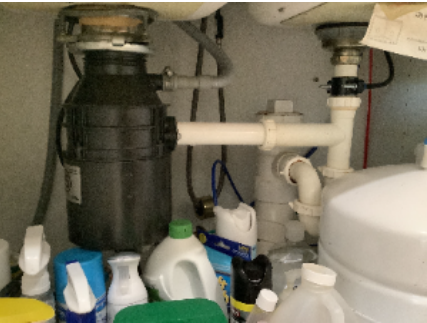
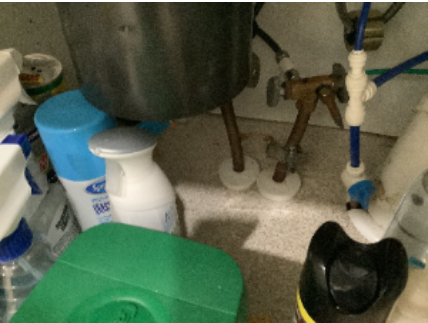
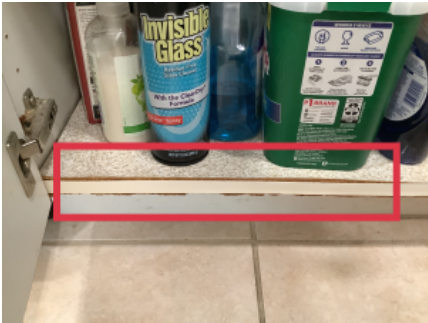
Monitor
Signs of spills and previous leaks. Noted Tested dry.

The base is beginning the delaminate at the front.

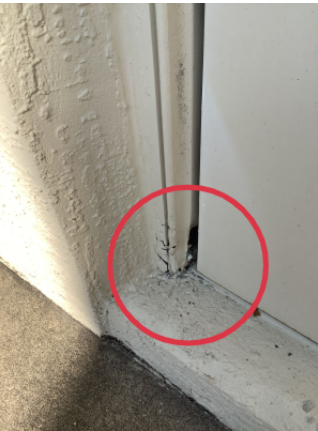
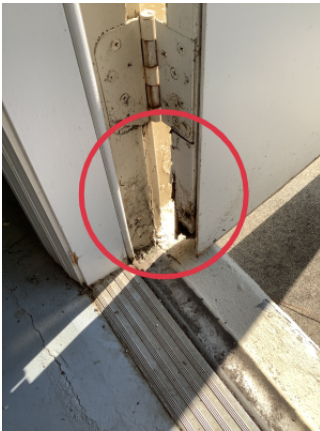
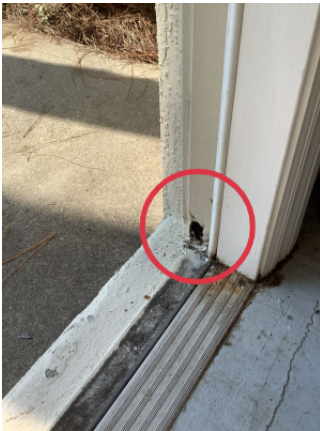
Repair or Replace
The side garage door is rotted and rusted. Repair or replacement recommended.

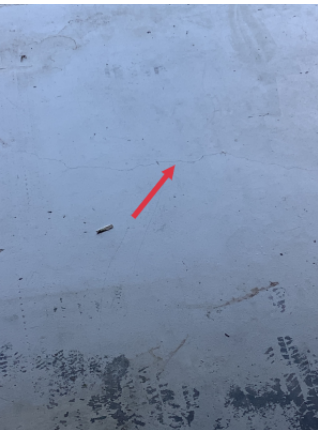
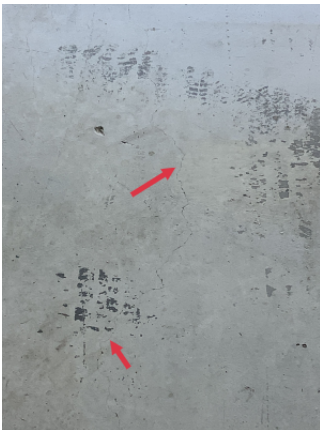
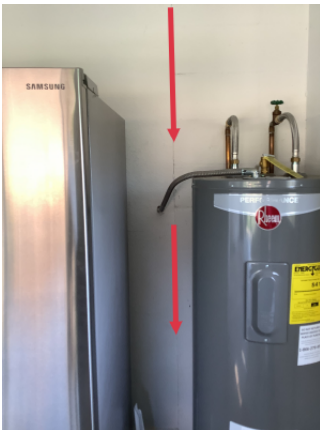
Monitor
Cracks in floor from settling. Recommend filling.
Recommend caulking seam behind water heater.

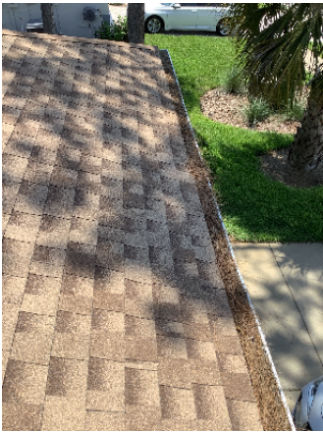
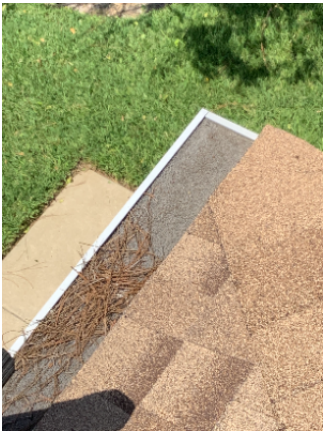
Description • Aluminum
Condition • Clogged

Monitor
Clean gutters. Recommended.

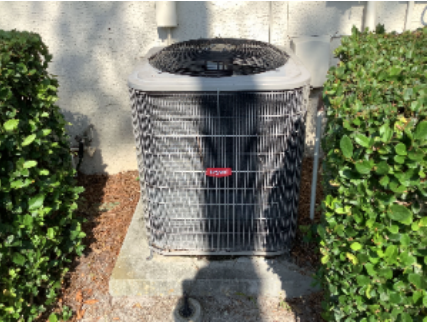
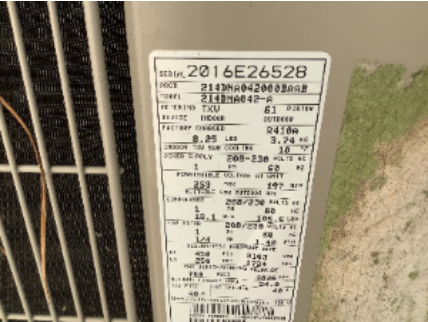
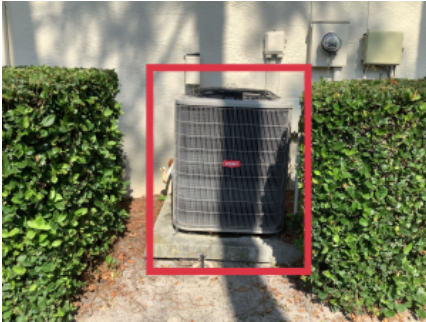
Monitor
The unit is not level. This puts extra wear on the fan motor. Recommend leveling.

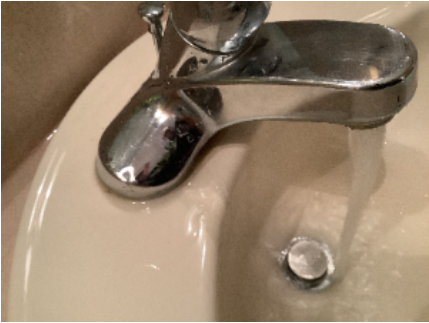
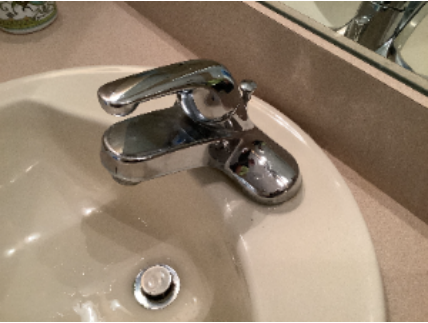
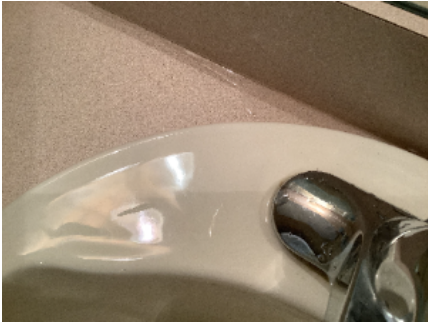
Description	• Stainless Steel	Repair or Replace
Condition	• Leaking	<i>Faucet leaks at the handle. The seal is probably bad. Repair needed.</i>
Location	• Guest Bathroom

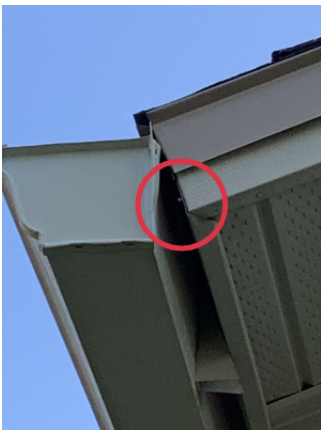
Image 1.2.1

- Metal
- Missing Caulking

Monitor Reset nails that have worked themselves out. Recommended.

Caulk seams where there are gaps where the fascia meets the soffit. Recommended.

Caulk seams where there are gaps where the fascia meets the structure.

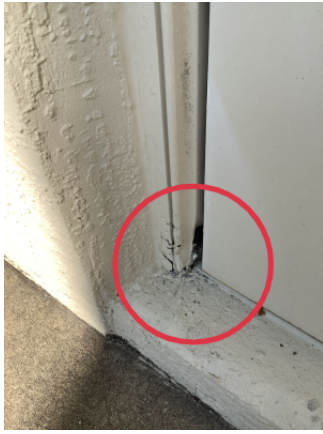
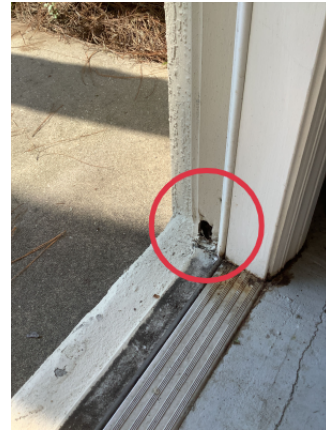
Image 1.3.1

Repair or Replace The side garage door is rotted and rusted. Repair or replacement recommended.

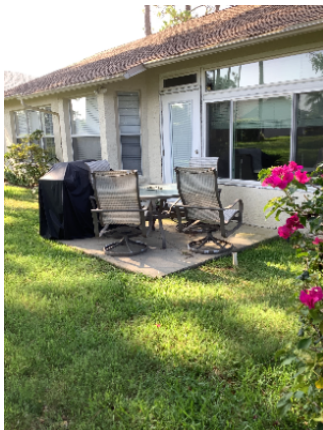
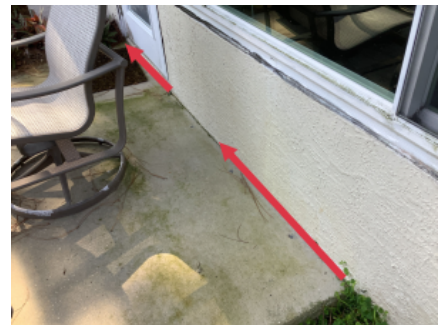
Image 1.4.1

- Concrete
- Normal Settling Cracks

Monitor Recommend filling cracks in patio slab. These are from normal settling.

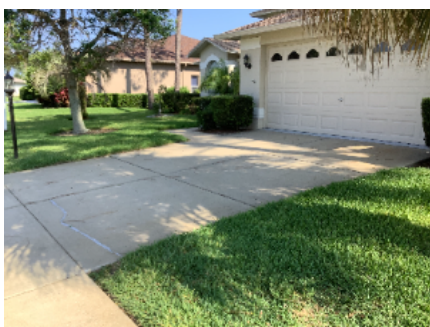
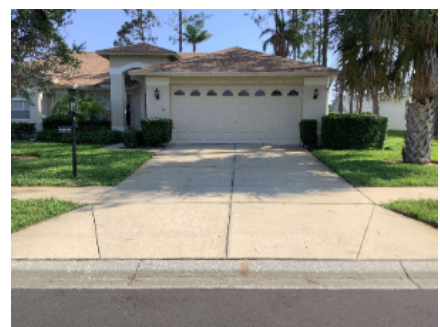
Image 1.7.1

Monitor There are predictable cracks in the driveway that would not necessarily need to be serviced.

Recommend filling the cracks to help prevent moisture intrusion under the slab.

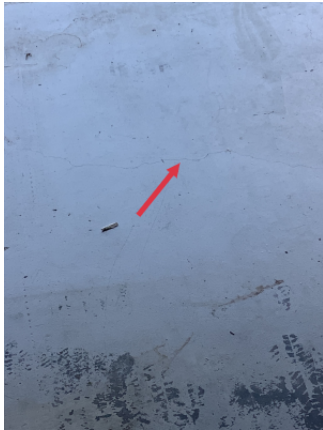
Image 1.8.1

Monitor Cracks in floor from settling. Recommend filling.

Recommend caulking seam behind water heater.

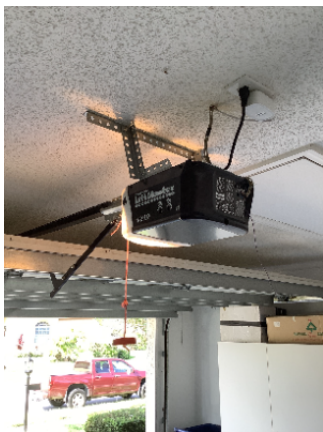
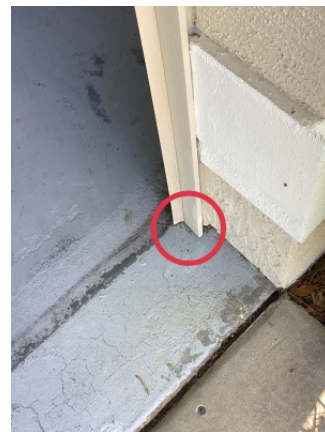
Image 1.9.1

- Missing
Caulking

Monitor Caulk all corners of the opening, recommended.

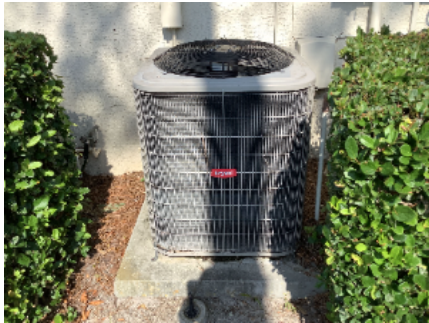
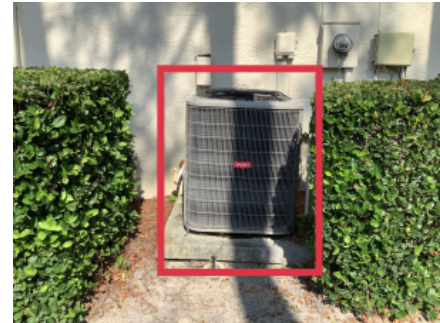
Image 4.3.1

Monitor The unit is not level. This puts extra wear on the fan motor. Recommend leveling.

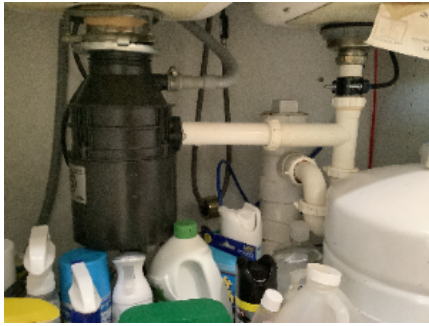
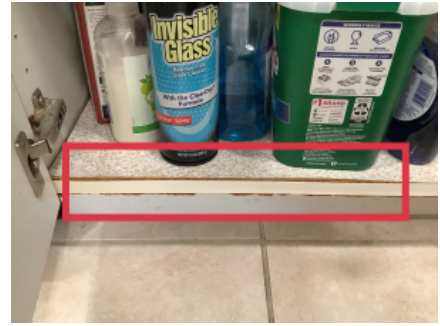
Image 5.2.1

Monitor Signs of spills and previous leaks. Noted Tested dry.

The base is beginning the delaminate at the front.

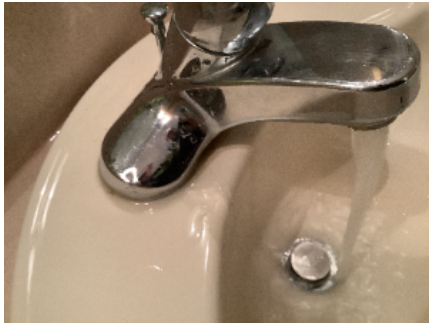
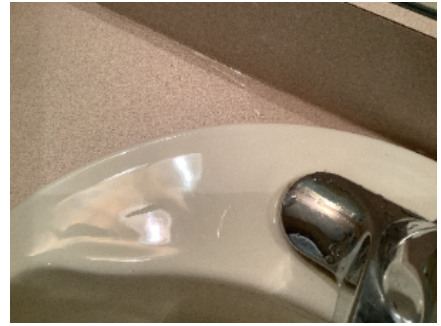
Image 5.5.1

Repair or Replace Faucet leaks at the handle. The seal is probably bad. Repair needed.

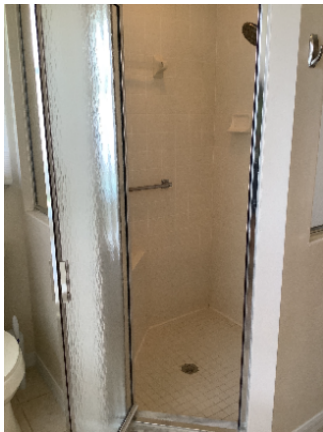
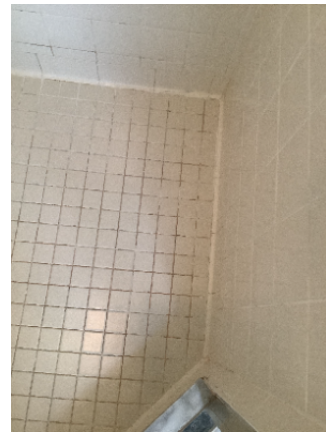
Image 5.8.1

- Missing Caulking

Monitor Scrub and clean shower tile. Once clean, fill in and replace any missing grout, caulk along bottom, caulk in front of the shower if needed after cleaning.

Caulk outside corners. Recommended.

Caulk in front of the shower. Recommended.

Caulk or grout any gaps in grout lines.
