# Property Inspection Report

## Demo Report Las Vegas, NV 89119

Date of Inspection  
**January 11th, 2023**  
**11:29 AM**

Inspected By  
**Brent Noisette**

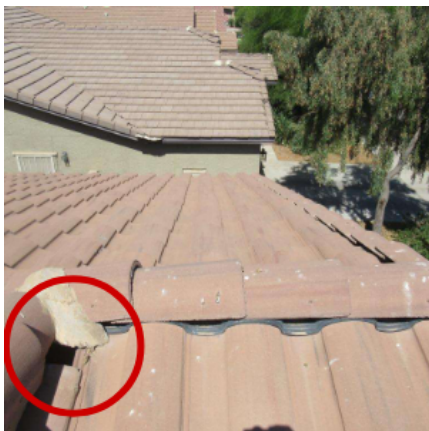
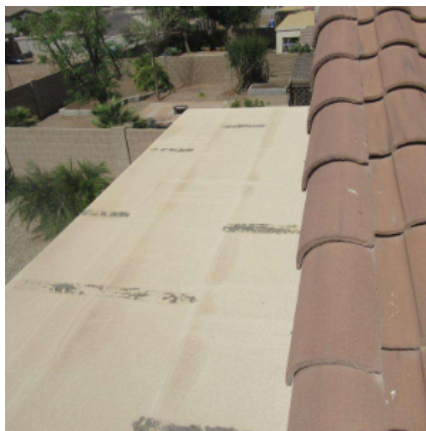
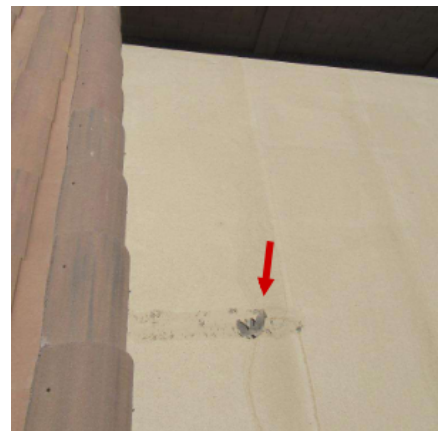
*Tile slipped from original position at north center gable above garage. Repairs may be made by the homeowner or a handyman.*

*Peeling coating from roofing joints on the south patio roof.*

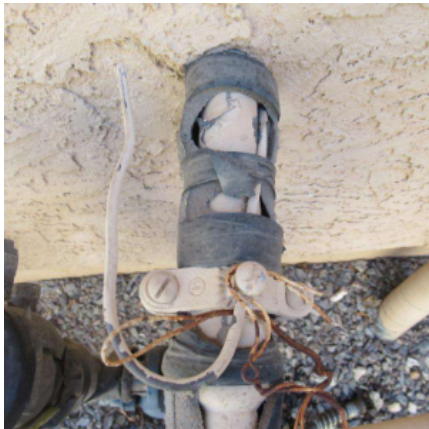
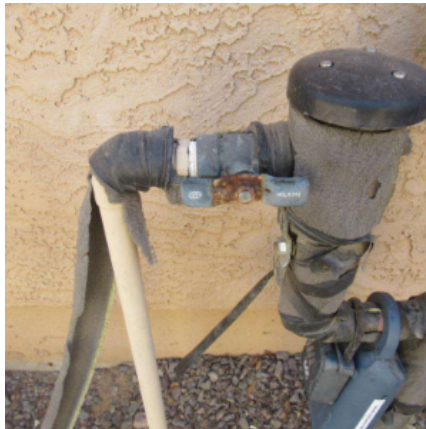
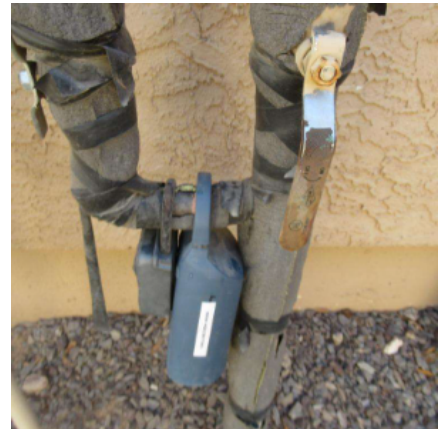
| | Condition | • Deteriorated Insulation | Risk | • West Side<br>• Freezing during extreme weather in winter |

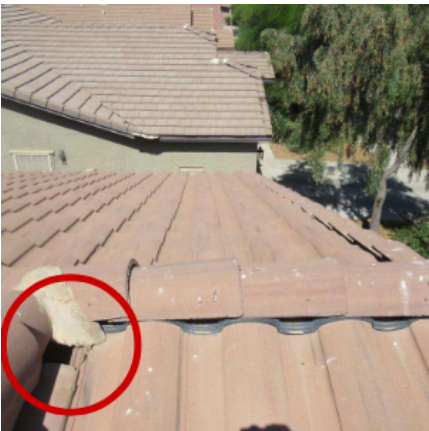
**Repair or Replace - Immediately:** Tile slipped from original position at north center gable above garage. Repairs may be made by the homeowner or a handyman.

Image 2.2.1 Roof tile has slid out of place - NE Corner of Home

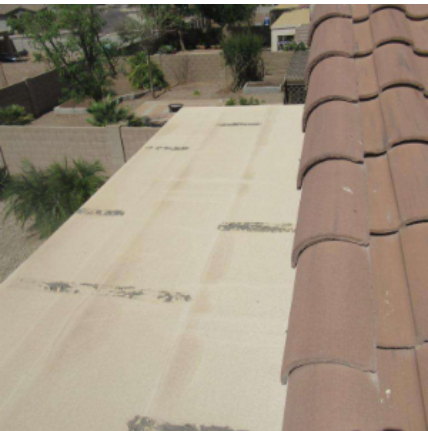
Peeling coating from roofing joints on the south patio roof.

Image 2.2.2 Peeling coating from joints on patio roof

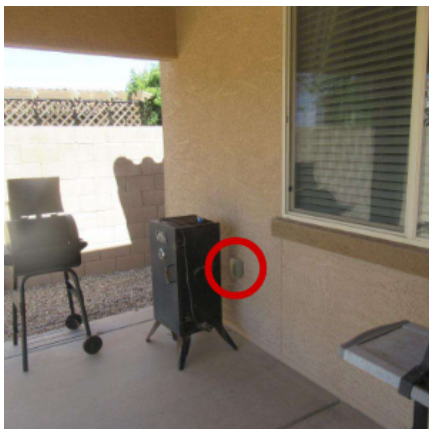
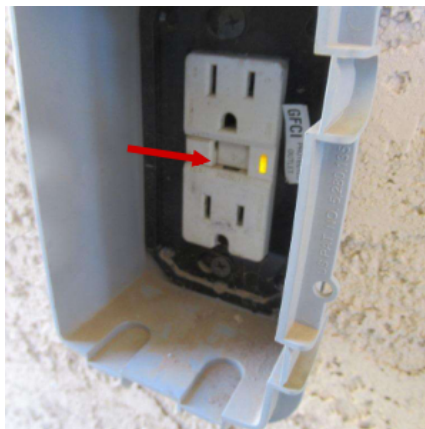
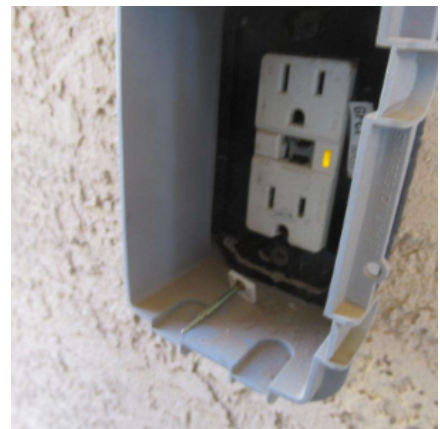
**Repair or Replace - Immediately:** The test button on the GFCI is broken and should be repaired or replaced immediately.

Image 3.3.1 Broken GFCI Location

Image 3.3.2 Broken GFCI Test Button

Image 3.3.3 Broken GFCI Test Button

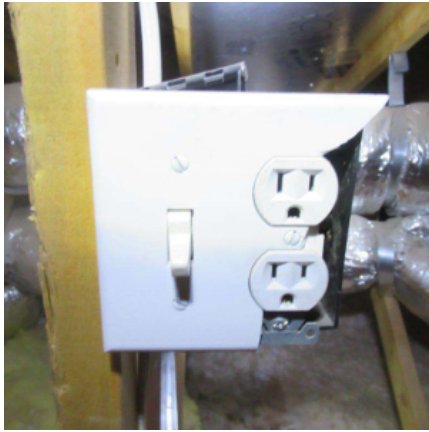
| Condition | <ul style="list-style-type: none"><li>• Damaged</li></ul> | Risk | <ul style="list-style-type: none"><li>• Electrocution Hazard</li></ul> |

Image 3.4.1 Broken Outlet Cover

**Repair or Replace**

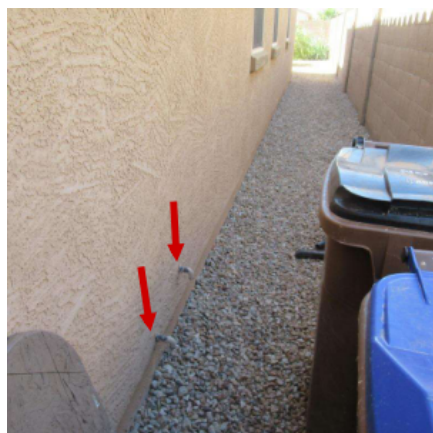
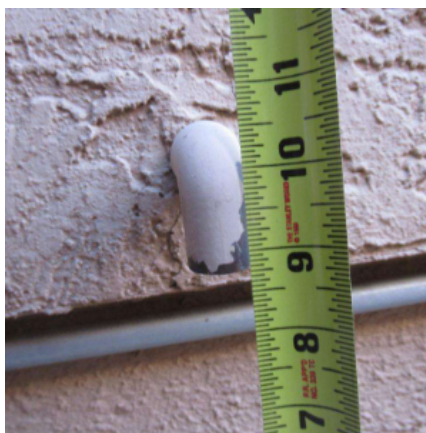
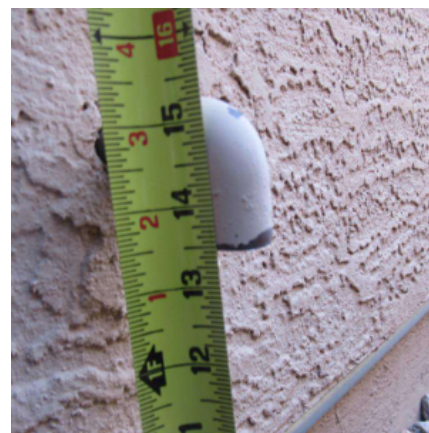
**Repair or Replace - Immediately:** Water heater discharge pipe is too short/far from ground. Steam dissipation can cause scalding to those standing nearby. Typically this should terminate 6 inches from the ground, but may vary by jurisdiction.

Image 5.1.1 Discharge Pipes on West Wall

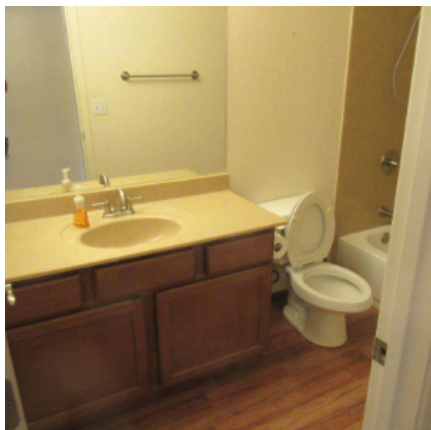
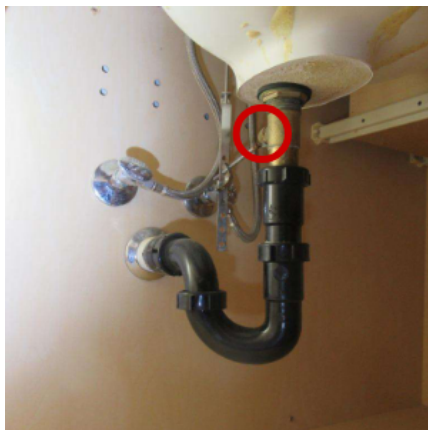
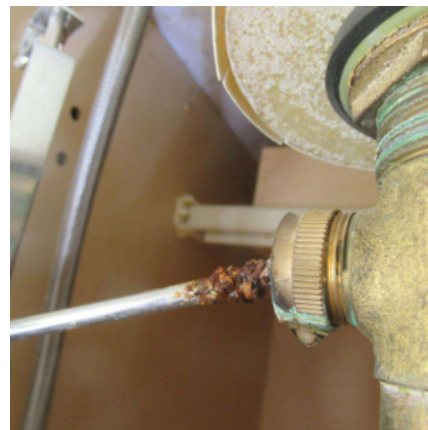
**Repair or Replace - Immediately:** A leak is present at the stopper rod/drain connection. The mechanism can be dismantled to check seals for wear or cracks.

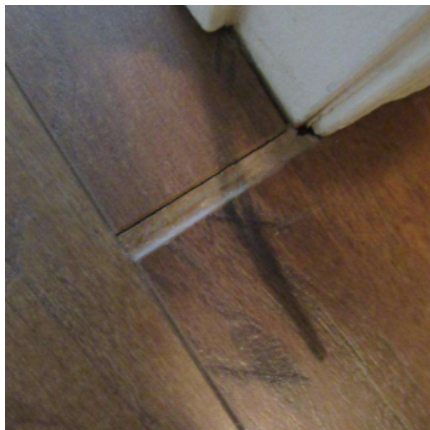
Image 6.1.1 Hardwood Flooring Gap - Master Bdrm Entry

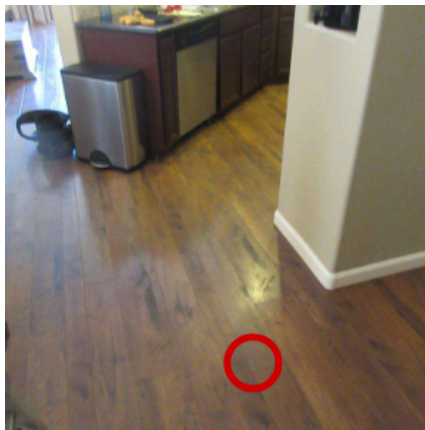
**Monitor** The corner of a hardwood flooring piece in the kitchen is delaminating and may get worse over time. Please monitor it at your discretion.

Image 6.1.2 Delamination spot in kitchen

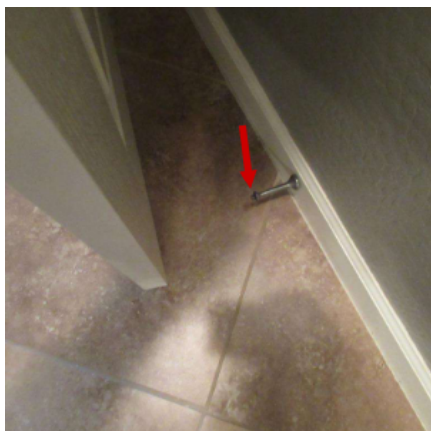
Image 6.2.1 Laundry Room

**Repair or Replace** Two of the door stops are missing the rubber bumpers that absorb the impact without denting the door. These can be purchased at your local hardware store and installed easily.
