# Property Inspection Report Summary

## Demo Report Las Vegas, NV 89119

Date of Inspection  
**January 11th, 2023**  
11:29 AM

**Vallarta Home & Rental Inspections**  
3223288725

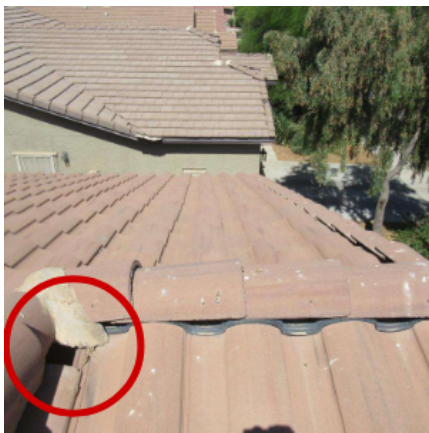
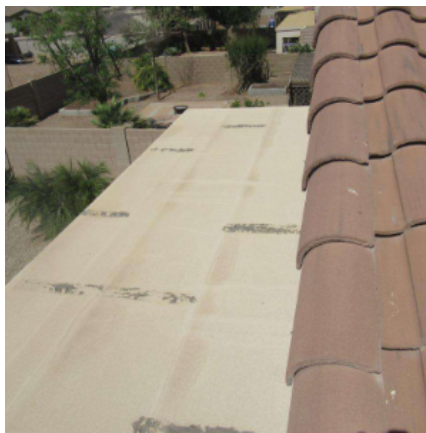
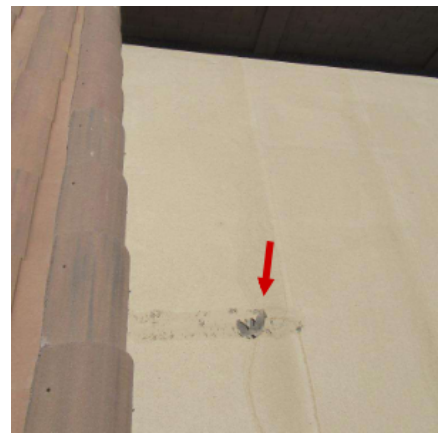
### Roof Coverings / Materials Section 2.2

| Description | <ul style="list-style-type: none"><li>Concrete Tile</li><li>Rolled Composite</li></ul> | <b>Repair or Replace - Immediately:</b><br><i>Tile slipped from original position at north center gable above garage. Repairs may be made by the homeowner or a handyman.</i> |
| Condition | <ul style="list-style-type: none"><li>Slipped</li><li>Peeling</li></ul> | |
| Location | <ul style="list-style-type: none"><li>Front of Home</li><li>Patio</li></ul> | <i>Peeling coating from roofing joints on the south patio roof.</i> |

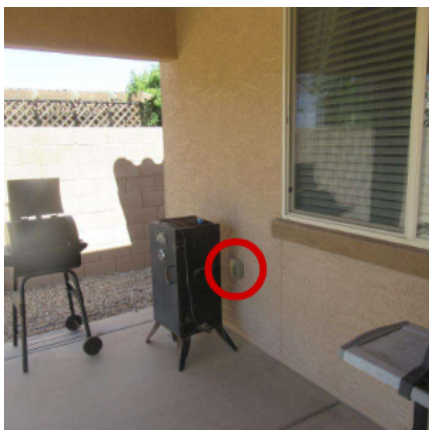
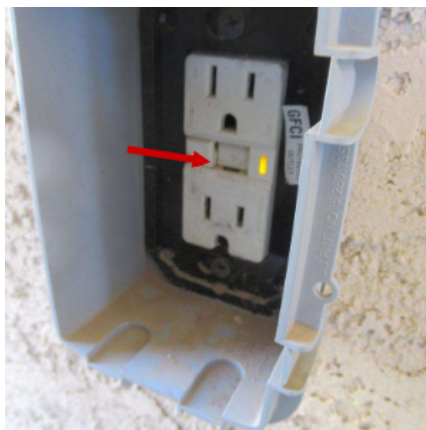
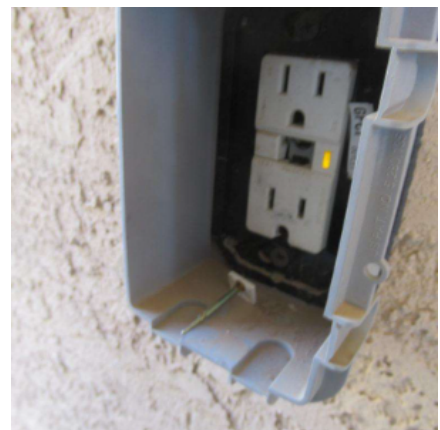
### GFCI Section 3.3

| Description | <ul style="list-style-type: none"><li>Present</li></ul> | <b>Repair or Replace - Immediately:</b><br><i>The test button on the GFCI is broken and should be repaired or replaced immediately.</i> |
| Condition | <ul style="list-style-type: none"><li>GFCI Inoperable</li></ul> | |
| Location | <ul style="list-style-type: none"><li>Exterior</li><li>South-West Corner</li></ul> | |

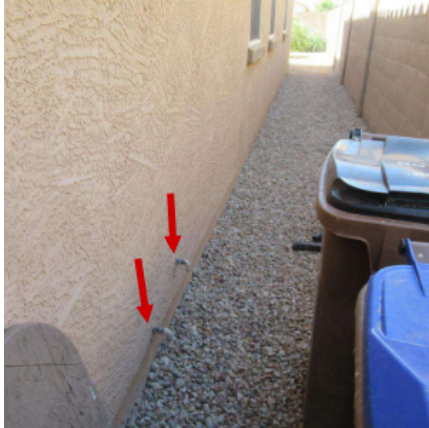
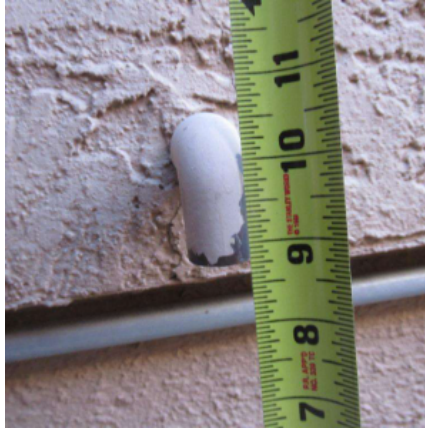
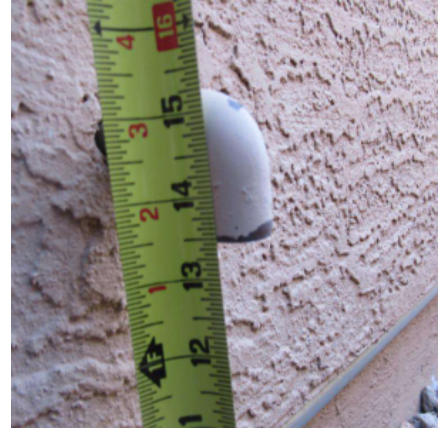
### Drain, Waste, Vent Piping Section 5.1

| Condition | <ul style="list-style-type: none"><li>• Improper Length</li></ul> |
| Location | <ul style="list-style-type: none"><li>• Exterior</li><li>• West Wall</li></ul> |

Water heater discharge pipe is too short/far from ground. Steam dissipation can cause scalding to those standing nearby. Typically this should terminate 6 inches from the ground, but may vary by jurisdiction.

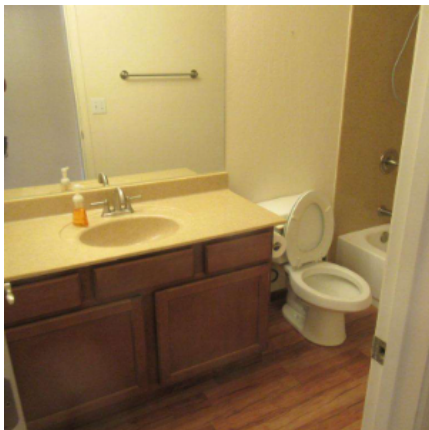
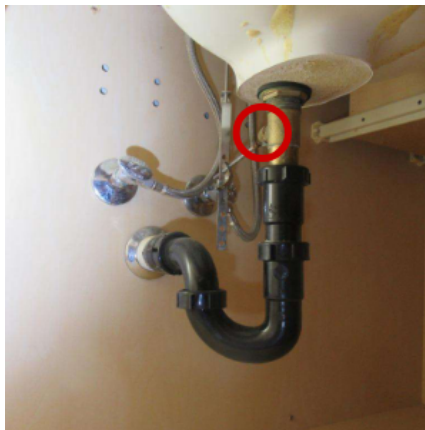
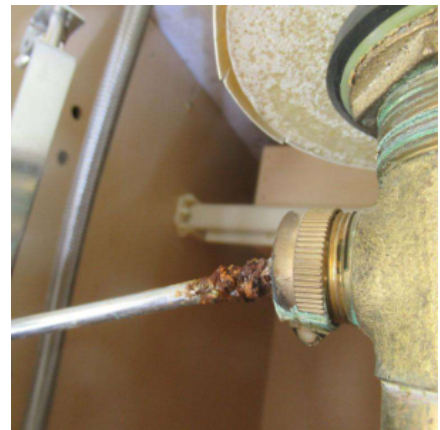
### Bathroom Sinks Section 5.2

| Condition | <ul style="list-style-type: none"><li>• Leaking</li></ul> |
| Location | <ul style="list-style-type: none"><li>• Master Bathroom</li></ul> |

A leak is present at the stopper rod/drain connection. The mechanism can be dismantled to check seals for wear or cracks.
