# Residential Inspection Report

## Sample Report Gillette, WY 82718

Date of Inspection  
**January 1st, 2024**  
12:00 PM

Inspected By  
**Jonathan la Cour**  
NACHI-23110211, CCPIA-002685

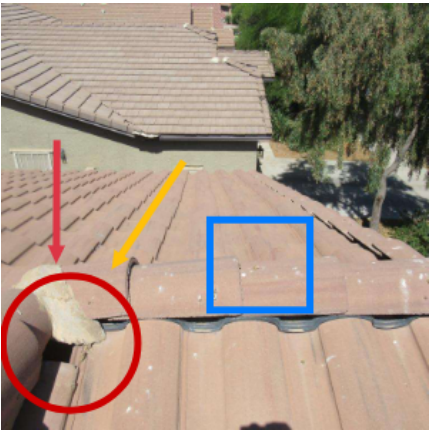
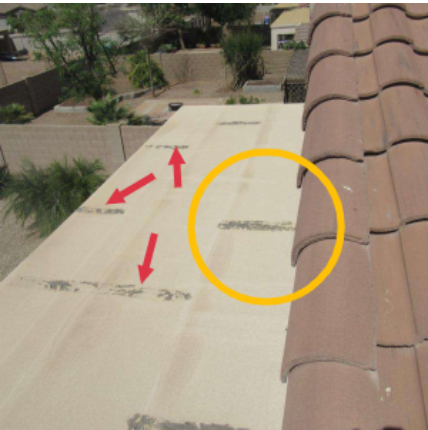
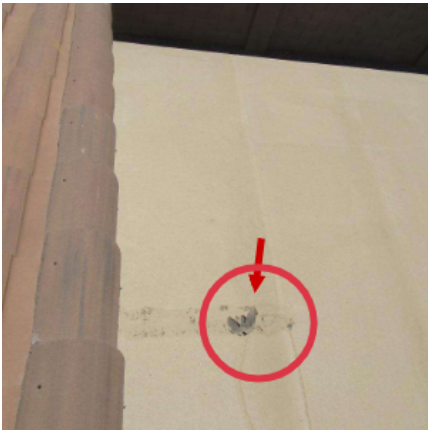
<b>Roof Coverings / Materials</b> Section 2.2 Page 10	<b>Description</b>	<ul style="list-style-type: none"><li>Concrete Tile</li><li>Rolled Composite</li></ul>	<b>Repair or Replace - Immediately:</b> <i>Tile slipped from original position at north center gable above garage. Repairs may be made by the homeowner or a handyman.</i>
	<b>Condition</b>	<ul style="list-style-type: none"><li>Slipped</li><li>Peeling</li></ul>	
	<b>Location</b>	<ul style="list-style-type: none"><li>Front of Home</li><li>Patio</li></ul>	<i>Peeling coating from roofing joints on the south patio roof.</i>

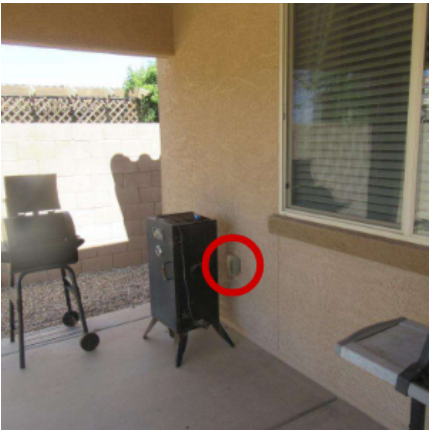
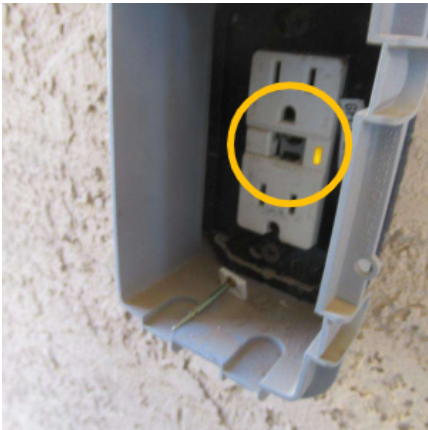
<b>GFCI</b> Section 3.3 Page 13	<b>Description</b>	<ul style="list-style-type: none"><li>Present</li></ul>	<b>Repair or Replace - Immediately:</b> <i>The test button on the GFCI is broken and should be repaired or replaced immediately.</i>
	<b>Condition</b>	<ul style="list-style-type: none"><li>GFCI Inoperable</li></ul>	
	<b>Location</b>	<ul style="list-style-type: none"><li>Exterior</li><li>South-West Corner</li></ul>

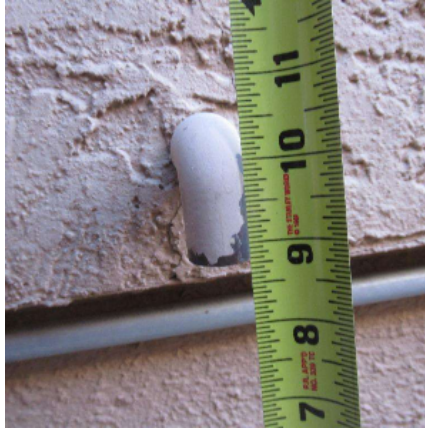
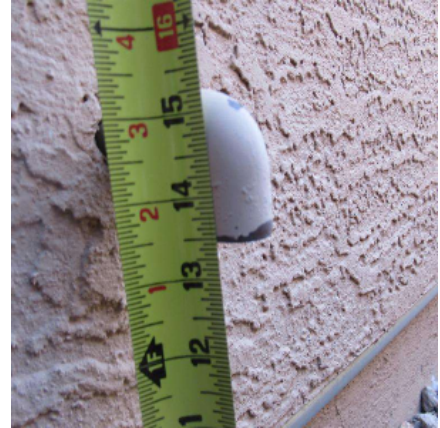
Water heater discharge pipe is too short/far from ground. Steam dissipation can cause scalding to those standing nearby. Typically this should terminate 6 inches from the ground, but may vary by jurisdiction.

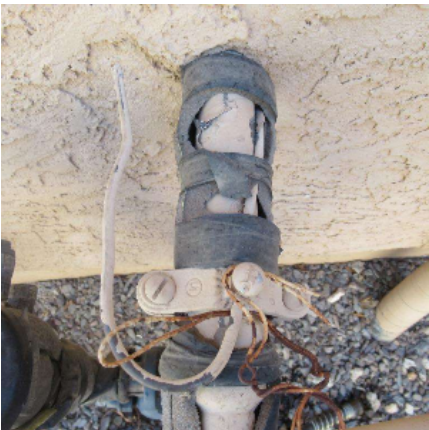
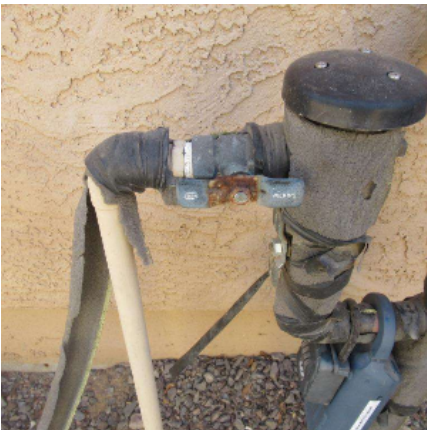
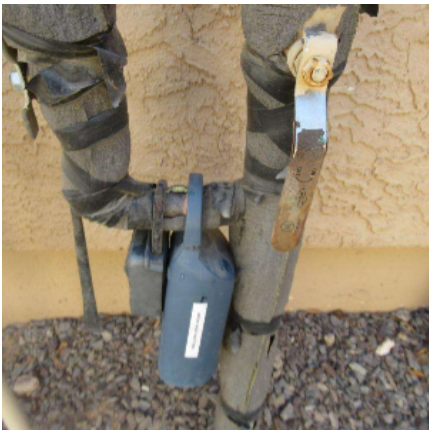
1.1 Hose Bibbs / Outdoor Faucets Exterior	Description	<ul style="list-style-type: none"><li>• Anti-siphon</li></ul>	Location	<ul style="list-style-type: none"><li>• Exterior</li><li>• West Side</li></ul>
	Condition	<ul style="list-style-type: none"><li>• Deteriorated Insulation</li></ul>	Risk	<ul style="list-style-type: none"><li>• Freezing during extreme weather in winter</li></ul>

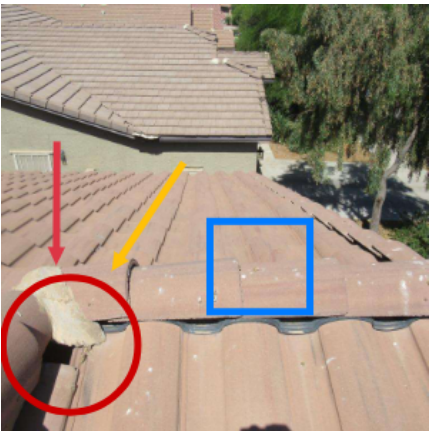
**Repair or Replace - Immediately:** Tile slipped from original position at north center gable above garage. Repairs may be made by the homeowner or a handyman.

Image 2.2.1 Roof tile has slid out of place - NE Corner of Home

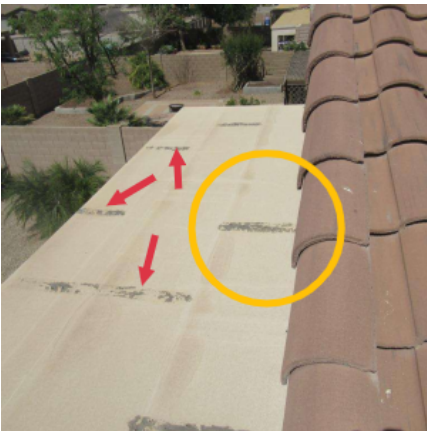
Peeling coating from roofing joints on the south patio roof.

Image 2.2.2 Peeling coating from joints on patio roof

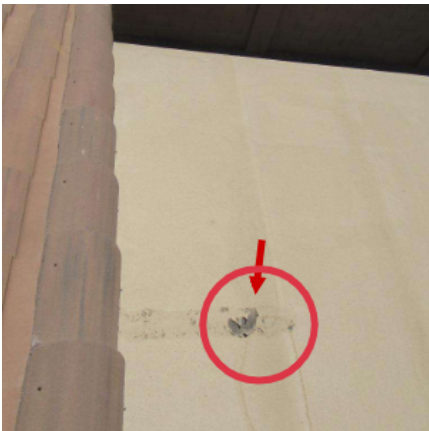
Image 2.2.3

2.2 Roof Coverings / Materials	Description	<ul style="list-style-type: none"><li>Concrete Tile</li><li>Rolled Composite</li></ul>	Location	<ul style="list-style-type: none"><li>Front of Home</li><li>Patio</li></ul>
Roofing	Condition	<ul style="list-style-type: none"><li>Slipped</li><li>Peeling</li></ul>

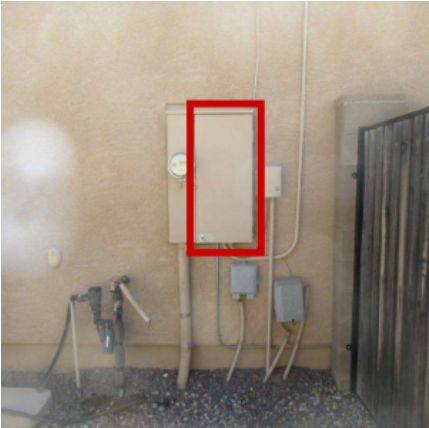
Image 3.2.1

3.2 Distribution Panels	Location	<ul style="list-style-type: none"><li>Exterior</li><li>West Side</li></ul>
-------------------------	----------	--

Please take note of the location of the panel, as it will need to be accessed to reset breakers during home ownership.

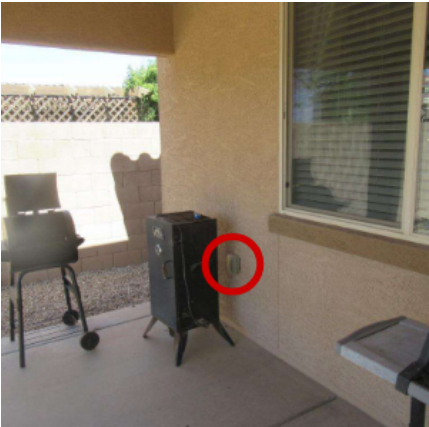
Image 3.3.1 Broken GFCI Location

**Repair or Replace - Immediately:** The test button on the GFCI is broken and should be repaired or replaced immediately.

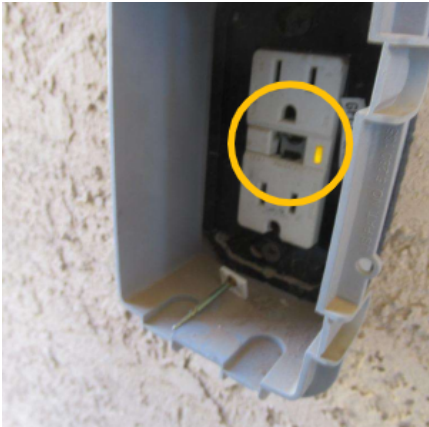
Image 3.3.2 Broken GFCI Test Button

Image 3.3.3 Broken GFCI Test Button

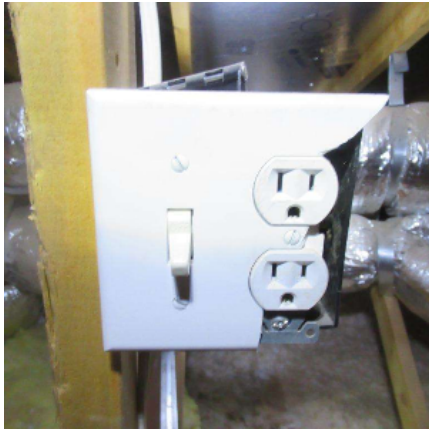
Description	<ul style="list-style-type: none"><li>• Switch/Outlet Combo Junction</li></ul>	Location	<ul style="list-style-type: none"><li>• Attic</li></ul>
Condition	<ul style="list-style-type: none"><li>• Damaged</li></ul>	Risk	<ul style="list-style-type: none"><li>• Electrocution Hazard</li></ul>

Image 3.4.1 Broken Outlet Cover

**Repair or Replace**

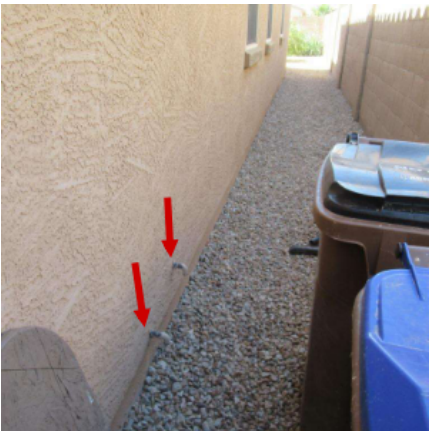
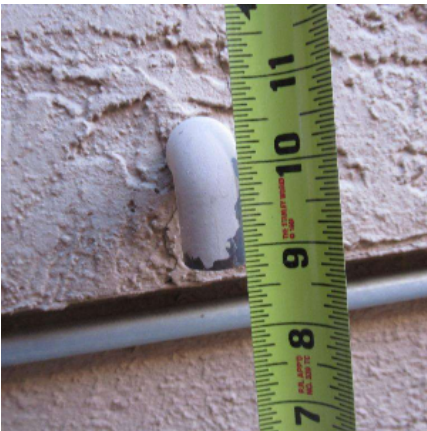
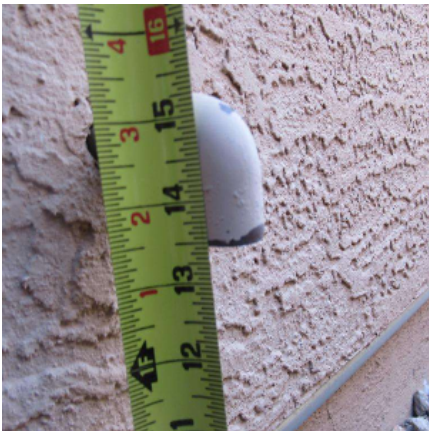
Image 5.1.1 Discharge Pipes on West Wall

5.1 Drain, Waste, Vent Piping Plumbing	Description	<ul style="list-style-type: none"><li>ABS Plastic</li><li>PVC</li></ul>	Location	<ul style="list-style-type: none"><li>Exterior</li><li>West Wall</li></ul>
	Condition	<ul style="list-style-type: none"><li>Improper Length</li></ul>	Risk	<ul style="list-style-type: none"><li>Safety Concern</li></ul>

**Repair or Replace - Immediately:** Water heater discharge pipe is too short/far from ground. Steam dissipation can cause scalding to those standing nearby. Typically this should terminate 6 inches from the ground, but may vary by jurisdiction.

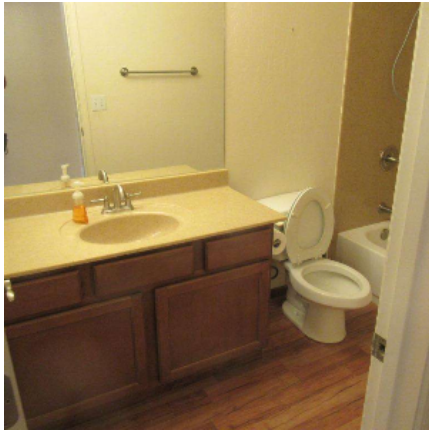
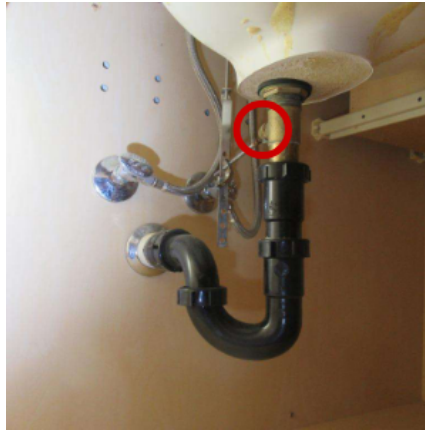
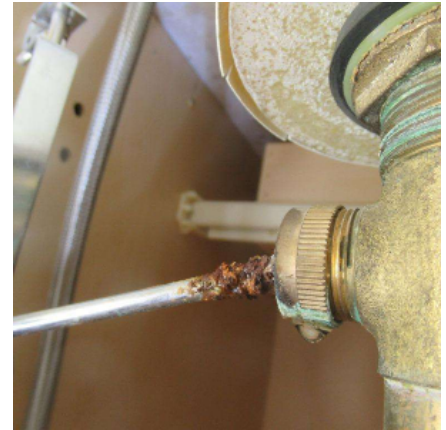
Image 5.2.1

- Leaking

**Repair or Replace - Immediately:** A leak is present at the stopper rod/drain connection. The mechanism can be dismantled to check seals for wear or cracks.

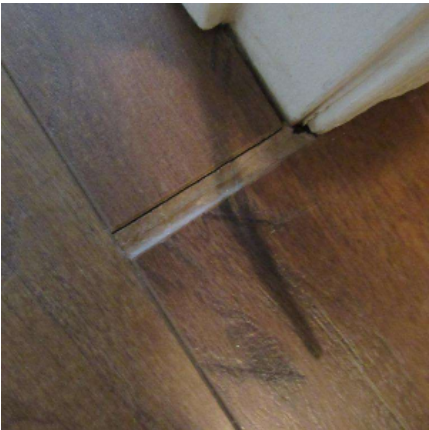
Image 6.1.1 Hardwood Flooring Gap - Master Bdrm Entry

**Monitor** The corner of a hardwood flooring piece in the kitchen is delaminating and may get worse over time. Please monitor it at your discretion.

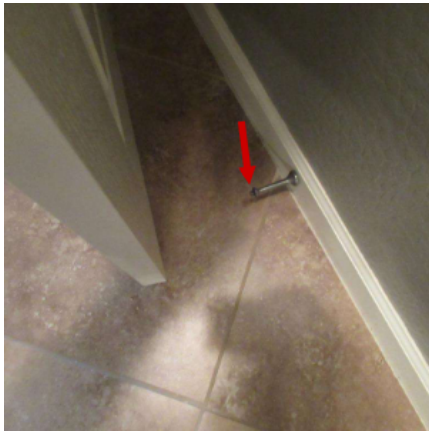
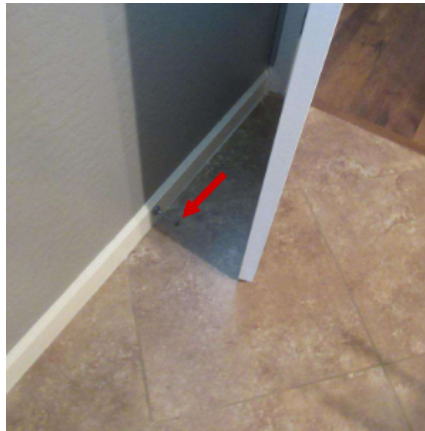
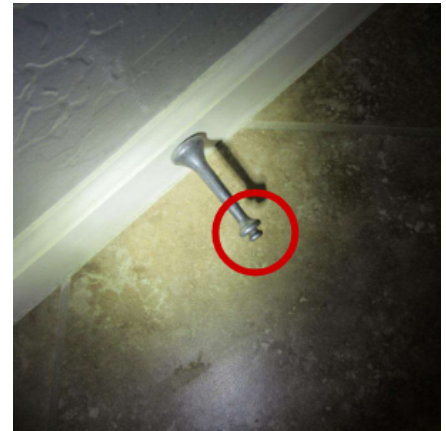
Image 6.2.1 Laundry Room

**Repair or Replace** Two of the door stops are missing the rubber bumpers that absorb the impact without denting the door. These can be purchased at your local hardware store and installed easily.

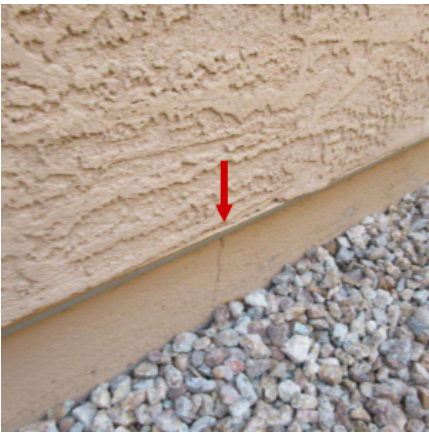
Image 7.1.1

7.1 Foundation Material Structure	Description	<ul style="list-style-type: none"><li>• Concrete</li></ul>	Location	<ul style="list-style-type: none"><li>• East Side of Home</li></ul>
	Condition	<ul style="list-style-type: none"><li>• Hairline Cracked</li></ul>	Risk	<ul style="list-style-type: none"><li>• Normal Settlement</li></ul>
There are typical settling cracks in the foundation walls that would not need a specialist evaluation.
