Property Inspection Report

**123 Dogwood Street
North Myrtle Beach, South Carolina 29582**

**April 24th, 2024
9:00 AM**

**Jason Brock
InterNACHI Certified Professional
Inspector**

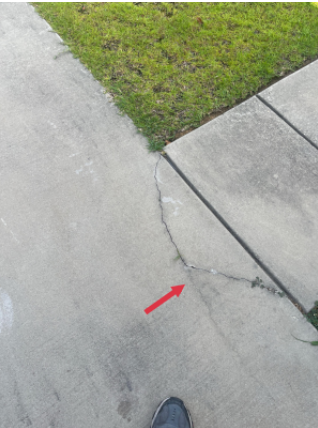
- Description
- Concrete
- Condition
- Observed minor cracking.

Minor cracks are expected in concrete driveways over time, but do not indicate a serious issue. Recommend sealing cracks to prevent water from seeping into cracks and eroding soil beneath the concrete.

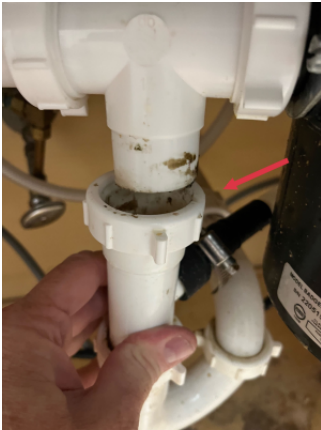
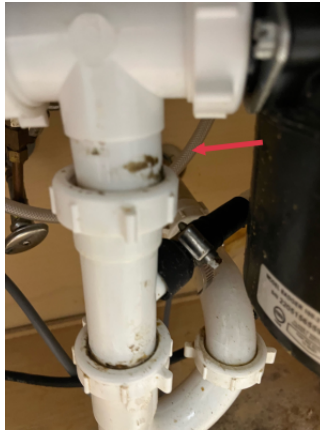
**Drain, Waste,
Vent Piping 2**
Section 5.2
Page 27

- Description**
- PVC
- Condition**
- Drain line under kitchen sink is loose and leaks when water is draining.
- Location**
- Under kitchen sink.

Repair or Replacement Needed
Recommend repair.

Leak is an easily correctable issue by handyman or plumber. Repair or Replacement of damaged cabinet bottom can be made by handyman or contractor,

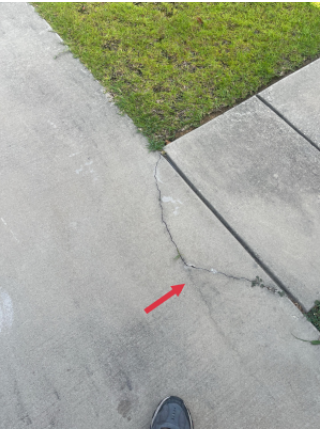
Image 1.12.1

Description	• Concrete
Condition	• Observed minor cracking.

Maintenance Needed Minor cracks are expected in concrete driveways over time, but do not indicate a serious issue. Recommend sealing cracks to prevent water from seeping into cracks and eroding soil beneath the concrete.

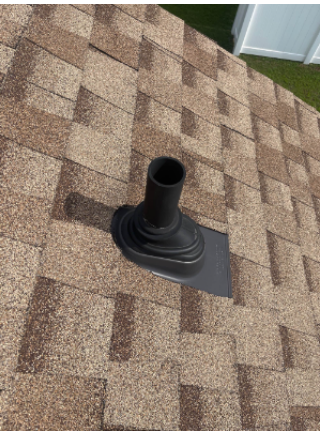
Image 2.1.1

2.1 Roof Coverings / Materials Roofing	Description	<ul style="list-style-type: none">• Architectural Shingle
	Condition	<ul style="list-style-type: none">• Shingles appear to be in very good condition with no visible areas of concern.

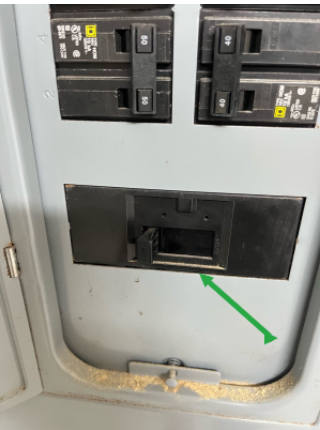
Image 3.2.1

Condition
- Breaker

- Functional
- Location
- Inside service panel in garage

The main disconnect (indicated by the green arrow in the photo) can be used to shut off all the electrical power to the home.

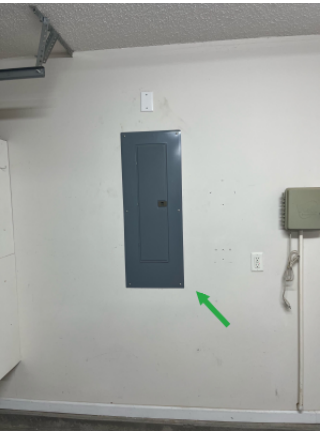
Image 3.3.1

Panels
Electrical

Condition • Functional

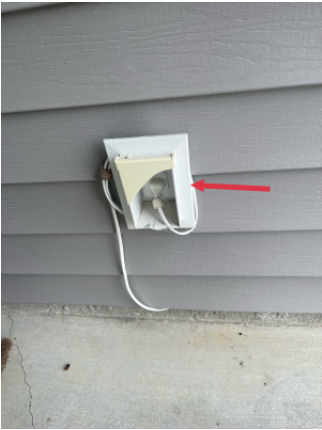
Image 3.6.1

Description • Functional
Condition • Cover for GFCI receptacle at the entrance of the front door is broken.
Location • Exterior receptical
Risk • Potential shock hazard if receptical gets wet.

Repair or Replacement Needed Recommend replacement of cover.

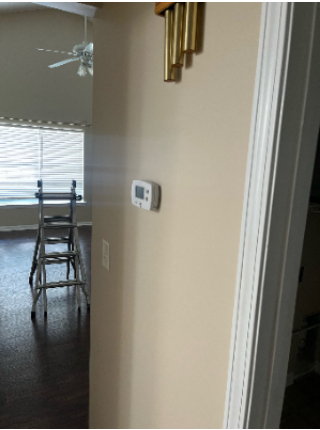
Image 4.2.1

4.1 Heating Systems HVAC	Description	<ul style="list-style-type: none">• Forced Air Furnace• Carrier	Location	<ul style="list-style-type: none">• Attic
	Condition	<ul style="list-style-type: none">• Unable to operate due to temperature outside. No visible defects observed.		
	System is 8 years old.			
4.2 Thermostats HVAC	Description	<ul style="list-style-type: none">• Digital	Location	<ul style="list-style-type: none">• Hallway leading to master bedroom.
	Condition	<ul style="list-style-type: none">• Functional

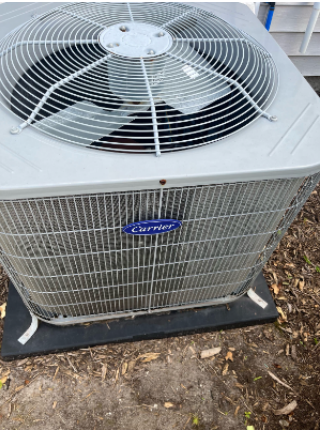
Image 4.3.1

Description	<ul style="list-style-type: none">• Central Split System.• Carrier	Location	<ul style="list-style-type: none">• Condenser unit located left side of house near garage walkout door.• Evaporator coil located in attic.
Condition	<ul style="list-style-type: none">• Functional		
System is 8 years old.

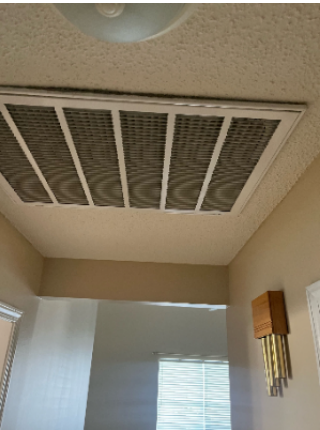
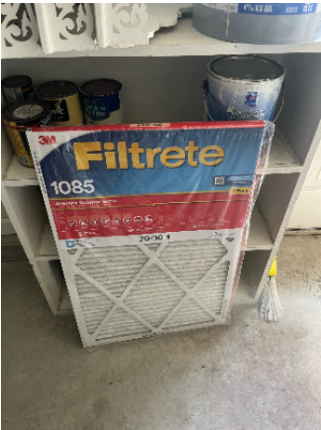
Image 4.6.1

Filter size is 20x30x1 inches.

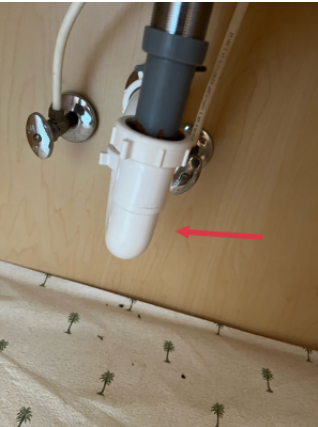
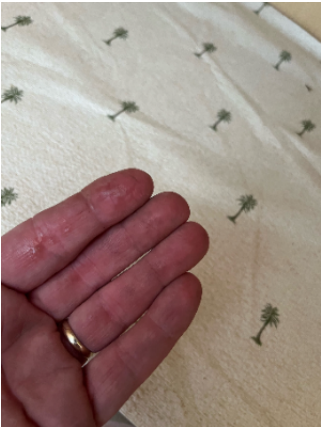
Image 5.1.1

5.1 Drain, Waste, Vent Piping 1 Plumbing	Description	<ul style="list-style-type: none">PVC	Location	<ul style="list-style-type: none">Guest bathroom under sink.
	Condition	<ul style="list-style-type: none">Minor leak observed when water is draining in guest bathroom sink.	Risk	<ul style="list-style-type: none">Potential damage to vanity base.

Repair or Replacement Needed P-trap under guest bath sink leaking. If left unrepaired, could lead to wood rot. This is an easily correctable issue for handyman or plumber.

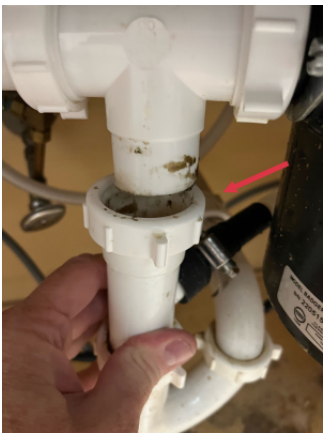
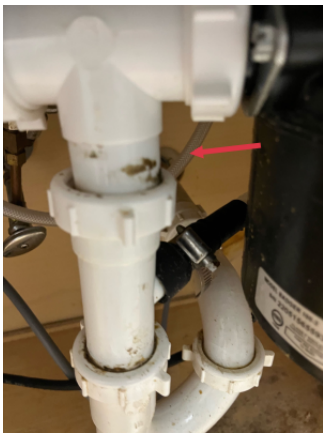
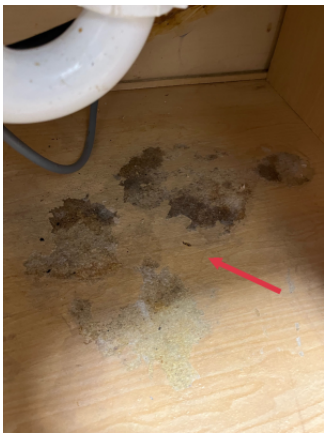
Image 5.2.1

5.2 Drain, Waste, Vent Piping 2 Plumbing	Description	<ul style="list-style-type: none">PVC	Location	<ul style="list-style-type: none">Under kitchen sink.
	Condition	<ul style="list-style-type: none">Drain line under kitchen	Risk	<ul style="list-style-type: none">Causing damage to bottom of base

sink is loose and leaks when water is draining. cabinet.

Repair or Replacement Needed Recommend repair.

Leak is an easily correctable issue by handyman or plumber. Repair or Replacement of damaged cabinet bottom can be made by handyman or contractor,

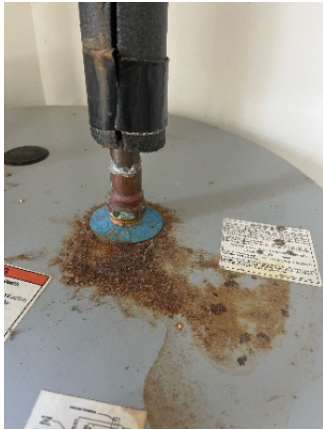
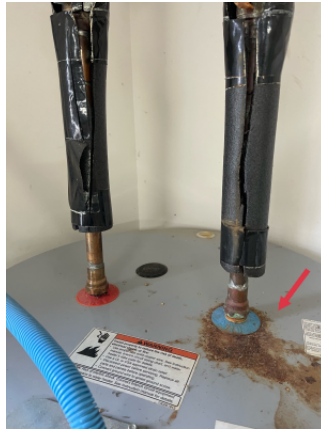
Image 5.3.1

Description • Conventional
Condition • Rust
 observed at
 cold water
 input line.

Further Evaluation Needed Minor rust was observed at cold water input line. No leak was observed. One possible reason for the cause of this rust could be galvanic reaction which is a chemical reaction of two different types of metals being connected together. Another possible cause could be from a previous leak that has since been repaired. However, unable to determine the exact cause of the rust. Recommend having condition checked by a licensed plumber.

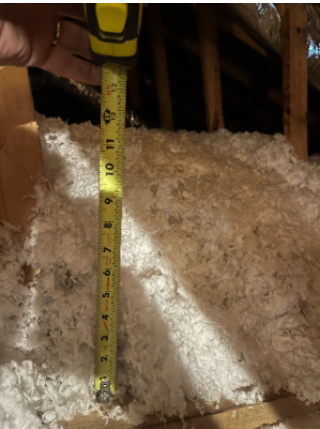
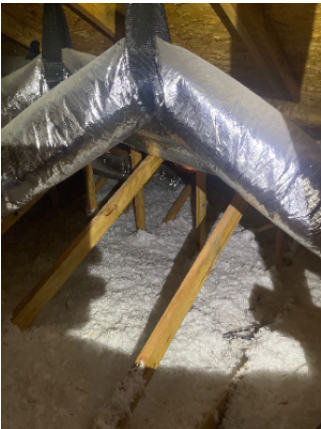
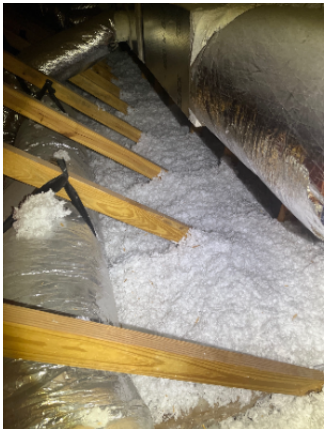
Image 8.2.1

8.1 Roof / Attic Insulation Insulation & Ventilation	Description	<ul style="list-style-type: none">Cellulose
	Condition	<ul style="list-style-type: none">Functional
8.2 Roof / Attic Insulation Depth Insulation & Ventilation	Description	<ul style="list-style-type: none">12 inches
	Condition	<ul style="list-style-type: none">Approximately R-38 Value.
