Property Inspection Report

Demo Report - 10013 River Drive Las Vegas, NV 89119

Date of Inspection
December 10th, 2020
11:30 AM

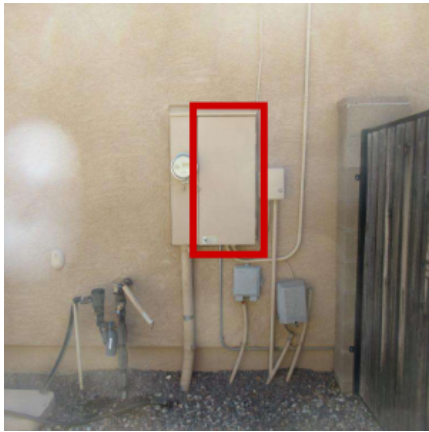
Image 3.2.1

Please take note of the location of the panel, as it will need to be accessed to reset breakers during home ownership.
