Property Inspection Report

**1234 Demonstration Way
Fort Lauderdale, FL 33304**

**July 16th, 2023
8:00 AM**

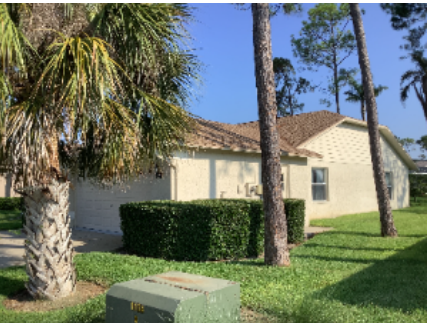
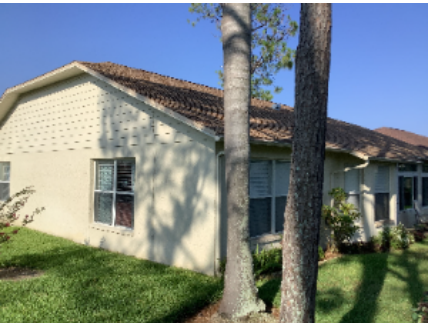
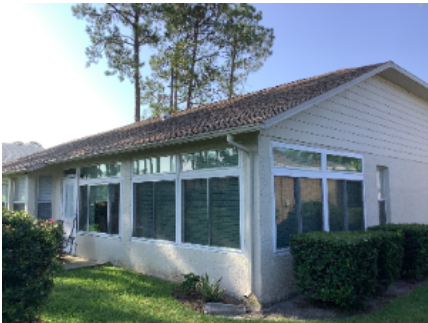
Trim / Fascia
Section 1.2
Page 17

| Condition | <ul style="list-style-type: none">• Missing Caulking |

Monitor
Reset nails that have worked themselves out. Recommended.

Caulk seams where there are gaps where the fascia meets the soffit. Recommended.

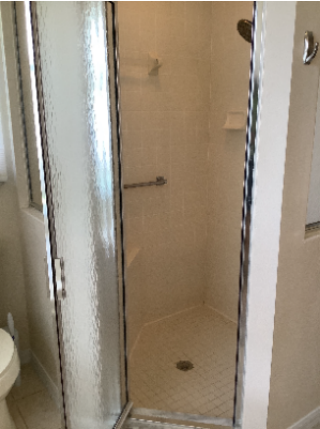
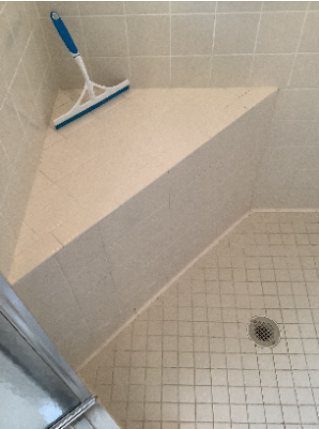
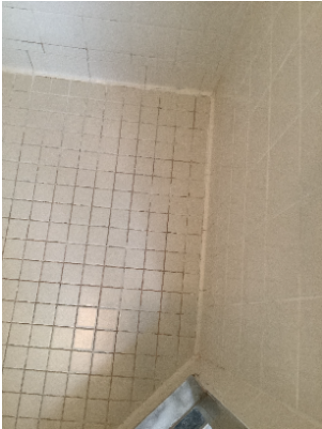
- Description
- Tile
- Condition
- Missing Caulking
- Location
- Master Bathroom

Monitor
Please see the corresponding section in the report body for additional notes.

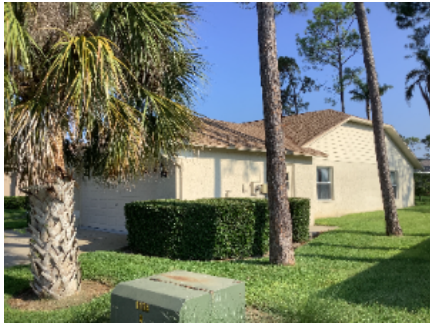
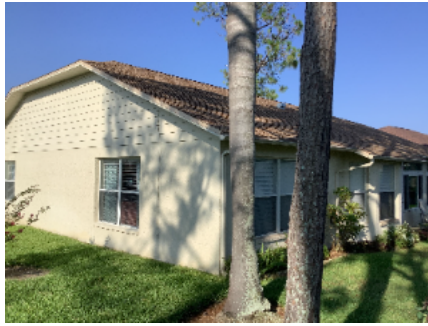
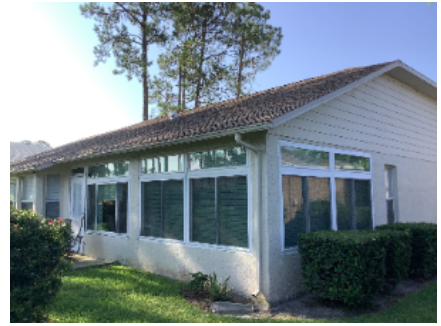
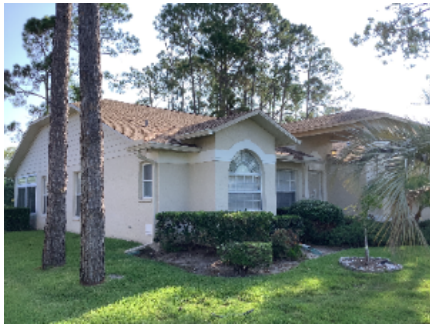
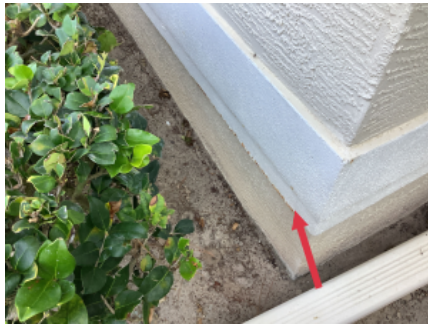
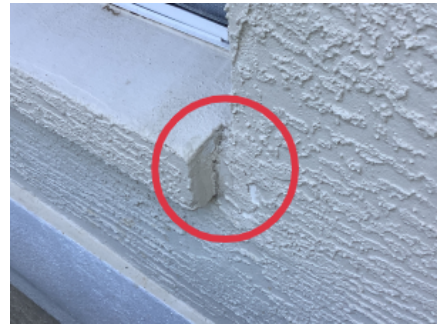
1.1 Exterior Wall Coverings Exterior	Description	<ul style="list-style-type: none">BlockStucco	Location	<ul style="list-style-type: none">Whole home
	Condition	<ul style="list-style-type: none">Missing CaulkingSee Additional Notes		
<p>Monitor Caulk gaps around pipes, cables, and wires that enter the home.</p> <p>Caulk or skim coat cracks in the stucco. These are from normal settling. Previous repairs noted. If cracking get worse, contact a licensed contractor.</p> <p>Caulk gaps in the window sill corners, recommended.</p> <p>Recommend caulking the edge of window frames with gaps.</p> <p>Caulk the bottom edge of the upper siding and maintain the paint.</p> <p>Metal flashing is rusted at front of home. Noted.</p> <p>Caulk base of exterior lights, recommended.</p> <p>Recommend caulking seams in the siding on either side of the home.</p> <p>Clean the caulking around the rear windows with an anti microbial. Recommend removing any that is damaged and reapplying. This is caused by the type of caulk used and the shaded area. .</p> <p>Clean the microbial growth from rear windows. Recommended. Caulk all seams with gaps.</p> <p>Recommend cleaning growth and dirt from exterior of home.</p> <p>Repair or replace damaged screens.</p>

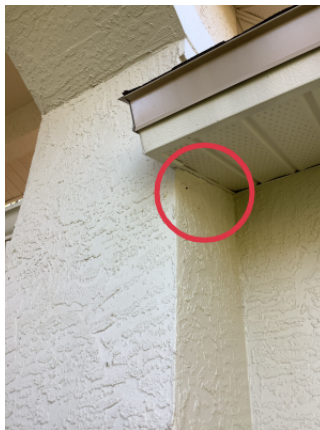
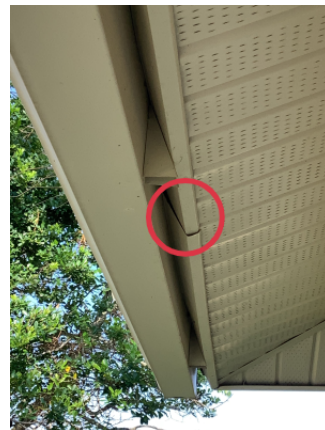
- Metal
- Missing Caulking

Monitor Reset nails that have worked themselves out. Recommended.

Caulk seams where there are gaps where the fascia meets the soffit. Recommended.

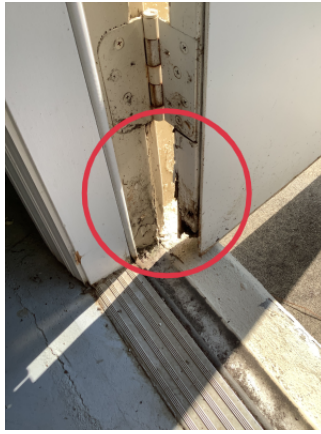
Image 1.3.1

- Rotted
- Rusted

Repair or Replace The side garage door is rotted and rusted. Repair or replacement recommended.

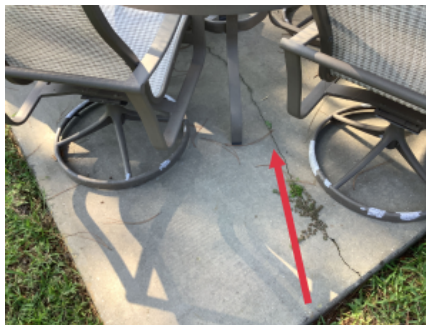
Image 1.4.2

- Concrete
- Normal Settling Cracks

Monitor Recommend filling cracks in patio slab. These are from normal settling.

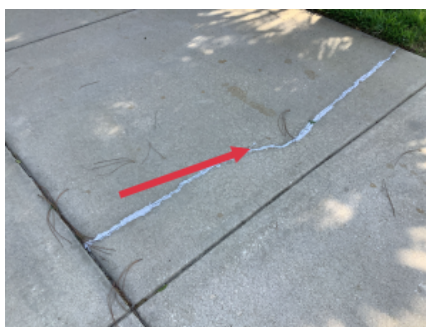
Image 1.7.2

- Concrete
- Normal Settling Cracks

Monitor There are predictable cracks in the driveway that would not necessarily need to be serviced.

Recommend filling the cracks to help prevent moisture intrusion under the slab.

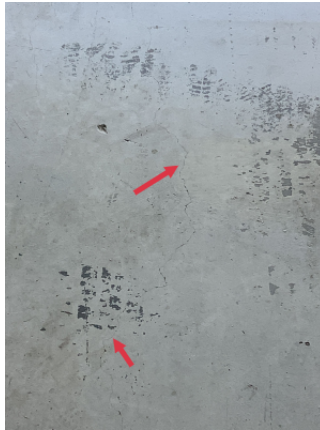
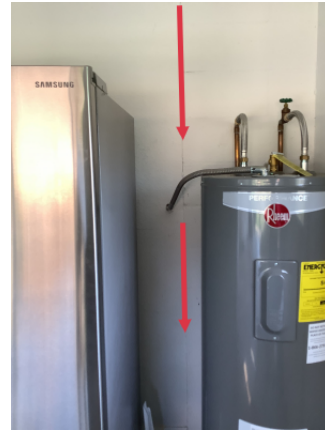
- Settling
Cracks

Monitor Cracks in floor from settling. Recommend filling.

Recommend caulking seam behind water heater.

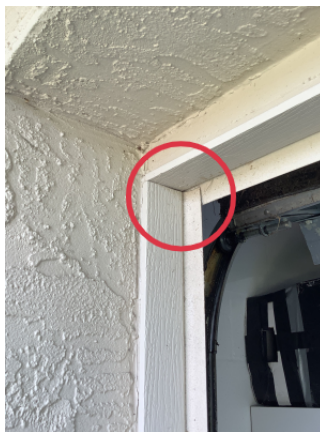
Image 1.9.2

- Missing
Caulking

Monitor Caulk all corners of the opening, recommended.

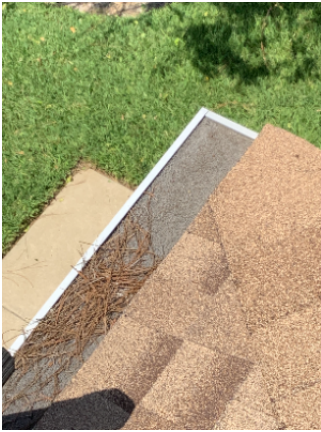
Image 2.2.2

2.2 Inner Eaves / Gutters	Description	<ul style="list-style-type: none">Aluminum
Roofing	Condition	<ul style="list-style-type: none">Clogged
	Monitor Clean gutters. Recommended.

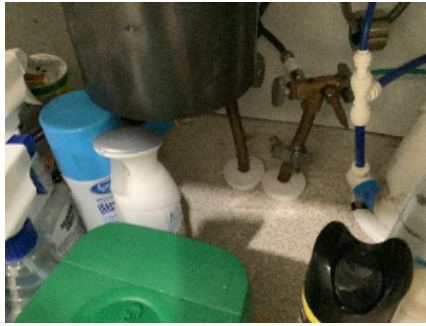
Image 5.2.2

5.2 Kitchen Basins Plumbing	Description	<ul style="list-style-type: none">Double Vanity	Location	<ul style="list-style-type: none">Kitchen
	Condition	<ul style="list-style-type: none">DrySigns of previous leaks/spills

Monitor Signs of spills and previous leaks. Noted Tested dry.

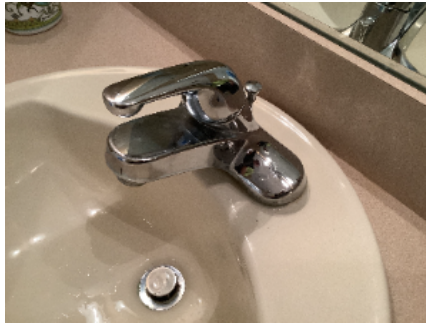
Image 5.5.2

Description	• Stainless Steel	Location	• Guest Bathroom
Condition	• Leaking

Repair or Replace Faucet leaks at the handle. The seal is probably bad. Repair needed.

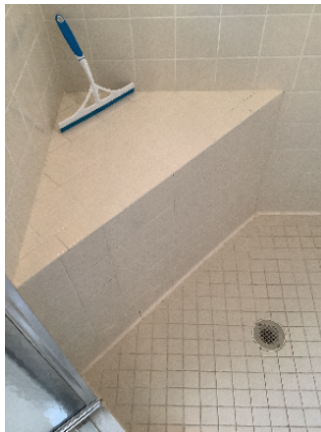
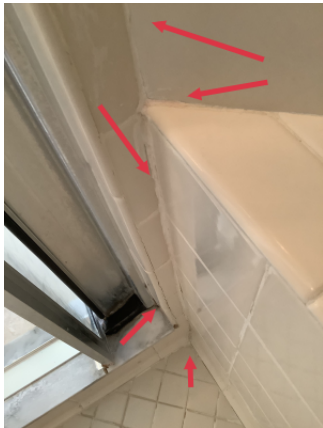
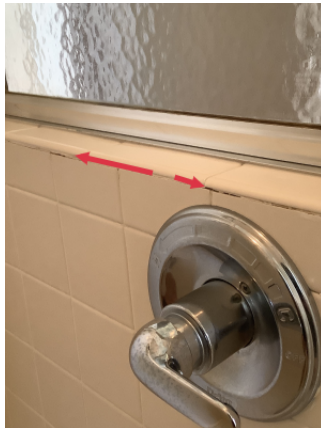
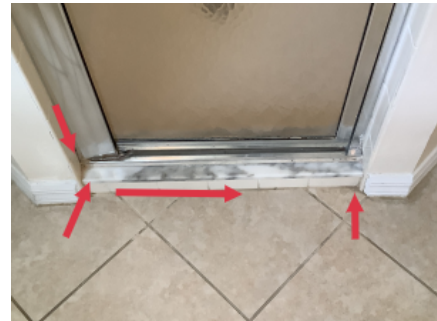
Condition

- Missing Caulking

Monitor Scrub and clean shower tile. Once clean, fill in and replace any missing grout, caulk along bottom, caulk in front of the shower if needed after cleaning.

Caulk outside corners. Recommended.

Caulk in front of the shower. Recommended.

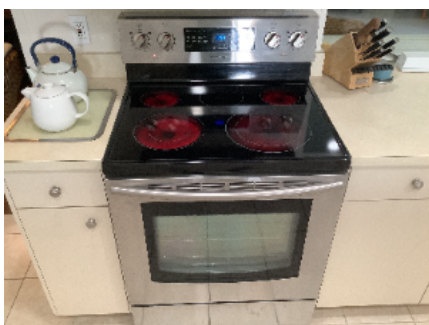
Image 6.7.1

Operated as required on day of inspection.

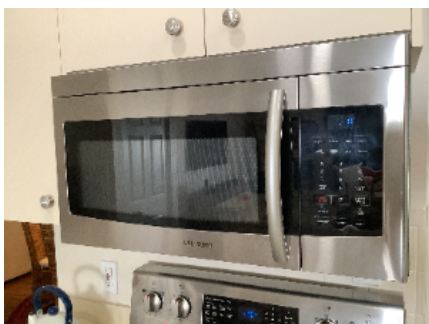
Image 6.10.1

Operated on day of inspection as required.
