# Property Inspection Report

## Demo Report Las Vegas, NV 89119

Date of Inspection  
**January 11th, 2023**  
**11:29 AM**

Inspected By  
**Brent Noisette**

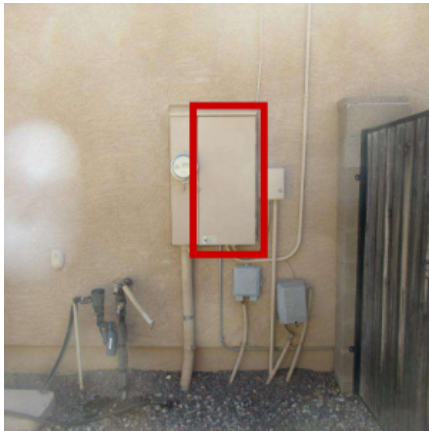
Image 3.2.1

Please take note of the location of the panel, as it will need to be accessed to reset breakers during home ownership.

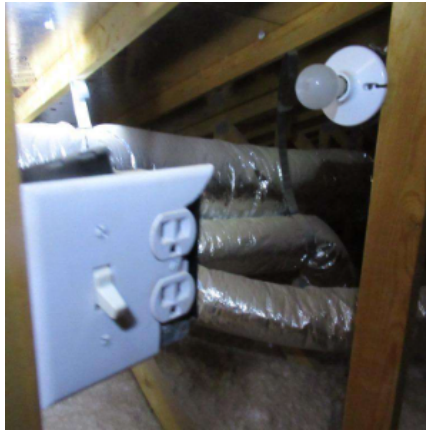
Image 3.4.2

| Condition | <ul style="list-style-type: none"><li>• Damaged</li></ul> | Risk | <ul style="list-style-type: none"><li>• Electrocution Hazard</li></ul> |

**Repair or Replace**

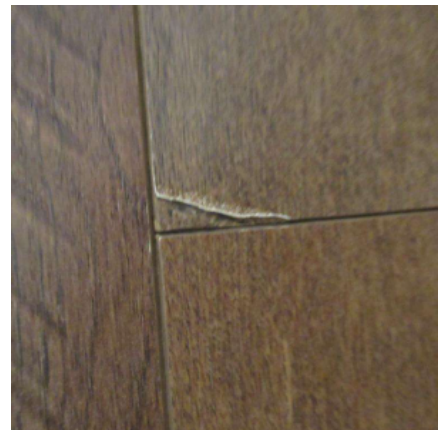
Image 6.1.3

| Condition | • Gap<br>• Minor Delamination | Risk | • Continued Delamination<br>• Cosmetic |
